## General Information

| Make | Toyota | Model | Fortuner |
| Registration No. | NHM9739 | Chassis No. | MHFCB3GS6R0495242 |

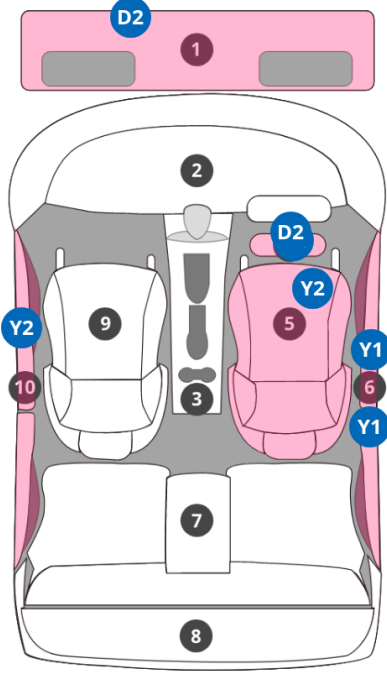
| Interior Evaluation : <b>B</b> | Exterior Evaluation : <b>C</b> |
| <p><b>Remarks</b><br/>Mat Other - Grime - Small / (R) Front Seat - Grime - Small / (R) Rear Trim - Grime - Minimal / (R) Front Trim - Grime - Minimal / (L) Front Trim - Grime - Small / Ceiling - Crinkle - Small / (L) Front Floor Mat - Worked - Small</p> | <p><b>Remarks</b><br/>(L) Front Door - Repair Traces - Yes / (R) Mirror - Scratch - Minimal / (R) Step, In-panel, Side Spoiler - Scratch - Minimal / (R) Front Door, Molding - Scratch - Small / (R) Rear Door, Molding - Scratch - Small / (R) Rear Fender, Molding - Scratch - Small / Rear Bumper, Lamps, Panels - Scratch - Small / Trunk Hood, Rear Gate - Scratch - Minimal / (L) Rear Fender, Molding - Scratch - Minimal / (L) Rear Door, Molding - Scratch - Minimal / (L) Front Door, Molding - Scratch - Small / (L) Mirror - Scratch - Minimal / (L) Step, In-panel, Side Spoiler - Scratch - Small / Front Bumper, Grille, Lamps - Scratch - Small / Bonnet, Headlight - Scratch - Minimal / Roof - Scratch - Medium</p> |

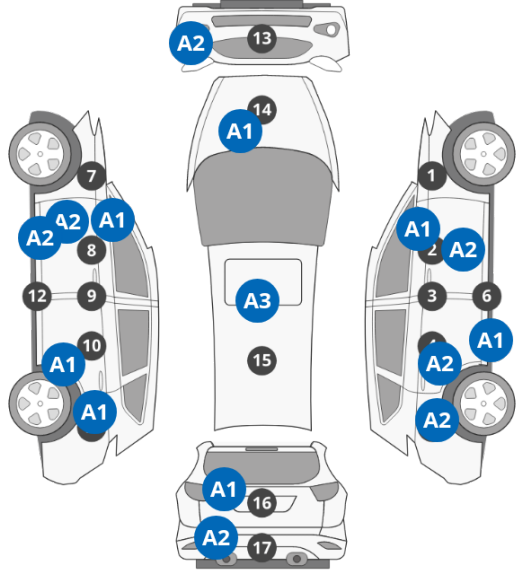
no warranty booklet, no jack, with tools, with spare tire, no LTO plate, R/HPG Recover, scratches on tail light,
