## General Information

| Make | Toyota | Model | Vios |
| Registration No. | NHS6478 | Chassis No. | PA1B18F33R4265091 |

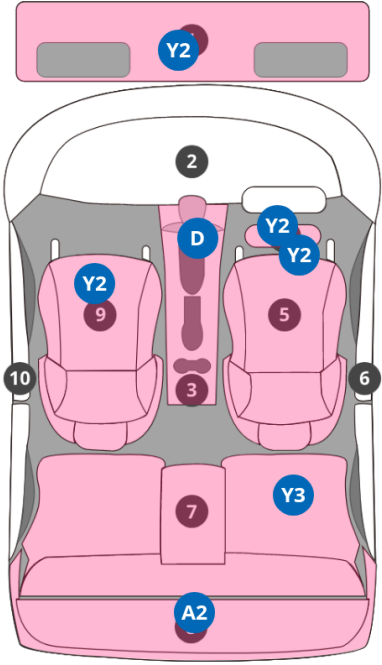
| Interior Evaluation : <b>B</b> | Exterior Evaluation : <b>C</b> |
|---|---|
| <p><b>a</b> : Cut, Fray <b>d</b> : Loose, Deformed <b>k</b> : Animal Hair <b>s</b> : Smell <b>t</b> : Cigarette Burns <b>x</b> : Defective <b>y</b> : Stain</p> | <p><b>A</b> : Scratch <b>AU</b> : Scratch &amp; Dent <b>B</b> : Modified <b>C</b> : Corrosion <b>G</b> : Stone chip <b>P</b> : Faded <b>S</b> : Rust <b>SC</b> : Rust &amp; Corrosion <b>U</b> : Dent <b>X</b> : Defective <b>Y</b> : Crack, Gap</p> |
| <p><b>Remarks</b><br/>Trunk Room - Worn, Scratch, Cut, Crack - Small / Rear Seat - Grime - Medium / (R) Front Seat - Grime - Small / Ceiling - Grime - Small / (L) Front Floor Mat - Grime - Small / (L) Front Seat - Grime - Small / Console, Switches, Vents - Traces of Adhesive Tape - Yes</p> | <p><b>Remarks</b><br/>(R) Front Fender, Molding - Scratch &amp; Dent - Medium / (R) Step, In-panel, Side Spoiler - Dent - Medium / (R) Mirror - Scratch - Minimal / (R) Front Door, Molding - Scratch - Minimal / (R) Rear Door, Molding - Scratch - Minimal / (R) Rear Fender, Molding - Scratch - Minimal / Rear Bumper, Lamps, Panels - Scratch - Minimal / Trunk Hood, Rear Gate - Scratch - Minimal / (L) Rear Fender, Molding - Scratch - Minimal / (L) Rear Door, Molding - Scratch - Minimal / (L) Front Door, Molding - Scratch - Minimal / (L) Front Fender, Molding - Dent - Medium / Front Bumper, Grille, Lamps - Scratch - Large / Roof - Scratch - Minimal / Bonnet, Headlight - Scratch - Minimal / (L) Mirror - Scratch - Minimal</p> |
