## General Information

| Make | Toyota | Model | Vios |
| YOM | 2024 | Odo Meter Reading | 6,849 |

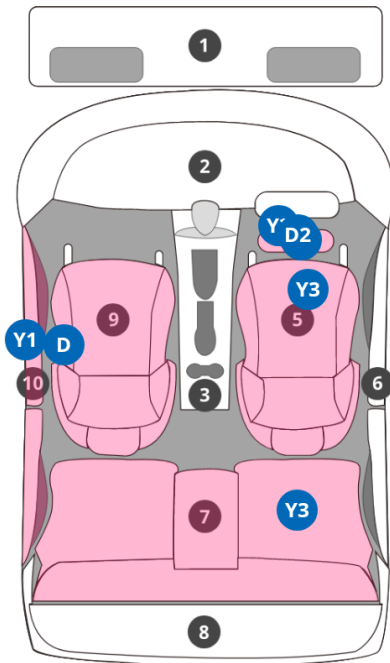
| Interior Evaluation : <span style="color: red;">C</span> | Exterior Evaluation : <span style="color: red;">B</span> |
| <p><b>Remarks</b></p> <p>Rear Seat - Grime - Medium / (R) Front Seat - Grime - Medium / (L) Front Seat - Worn - Yes / Mat Other - Grime - Small / (R) Front Floor Mat - Grime - Small / (L) Front Floor Mat - Worked - Small / (L) Front Trim - Grime - Minimal</p> | <p><b>Remarks</b></p> <p>(R) Front Fender, Molding - Scratch - Small / (R) Mirror - Scratch - Minimal / (R) Front Door, Molding - Scratch - Small / (R) Rear Door, Molding - Scratch - Minimal / (R) Rear Fender, Molding - Scratch - Minimal / Rear Bumper, Lamps, Panels - Scratch - Minimal / Trunk Hood, Rear Gate - Scratch - Small / (L) Rear Fender, Molding - Scratch - Small / (L) Rear Door, Molding - Scratch - Small / (L) Front Door, Molding - Scratch - Minimal / (L) Mirror - Scratch - Minimal / (L) Front Fender, Molding - Scratch - Minimal / Front Bumper, Grille, Lamps - Scratch - Minimal / Bonnet, Headlight - Scratch - Minimal / Roof - Scratch - Minimal</p> |

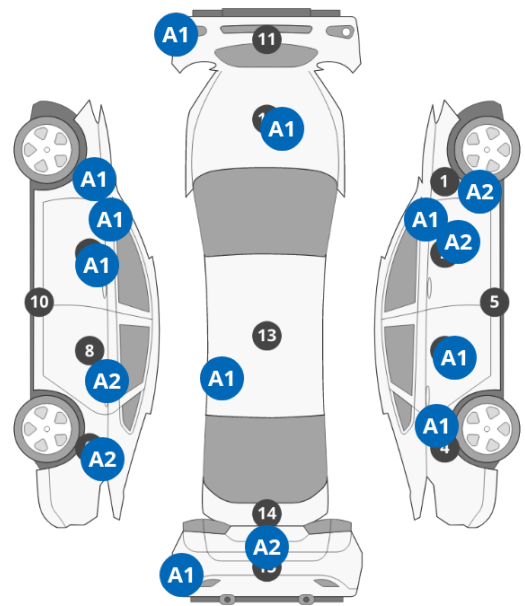
no warranty booklet, no jack, no tools, no spare tire, with LTO plate, scratches on tail light, power steering issue due to weak battery
