## General Information

| Make | Toyota | Model | Vios |
| YOM | 2024 | Odo Meter Reading | 16,827 |
| Registration No. | NKD7212 | Chassis No. | PA1B18F35R4258708 |

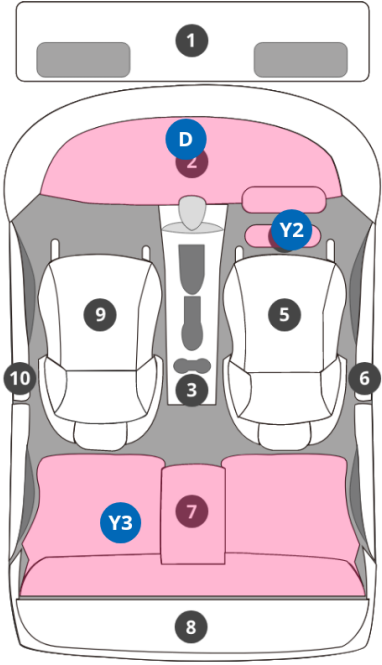
| Interior Evaluation : <b>B</b> | Exterior Evaluation : <b>B</b> |
| <b>Remarks</b><br>Dashboard - Traces of Adhesive Tape - Yes / (L) Front Floor Mat - Grime - Small / Rear Seat - Grime - Medium | <b>Remarks</b><br>Bonnet, Headlight - Scratch & Dent - Medium / Front Bumper, Grille, Lamps - Scratch & Dent - Small / (R) Rear Door, Molding - Scratch - Minimal / (R) Rear Fender, Molding - Scratch - Small / Rear Bumper, Lamps, Panels - Scratch - Medium / (L) Mirror - Scratch - Minimal / (L) Front Door, Molding - Scratch - Minimal / Trunk Hood, Rear Gate - Scratch - Minimal / (L) Rear Fender, Molding - Scratch - Minimal |
