## General Information

| Make | Toyota | Model | Wigo |
| Registration No. | DAR2266 | Chassis No. | MHKA4DF5FNJ070901 |

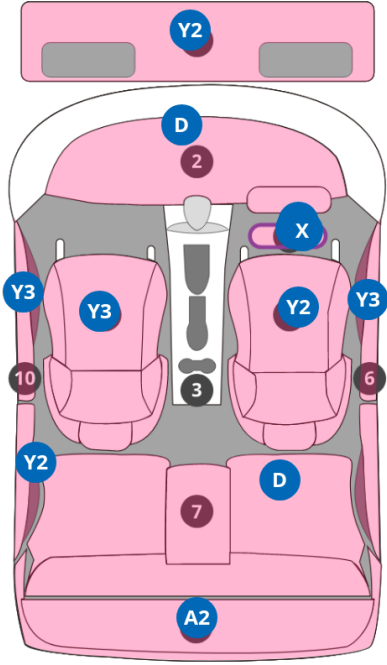
| Interior Evaluation : <b>C</b> | Exterior Evaluation : <b>D</b> |
|---|---|
| <p><b>a</b> : Cut, Fray <b>d</b> : Loose, Deformed <b>k</b> : Animal Hair <b>s</b> : Smell <b>t</b> : Cigarette Burns <b>x</b> : Defective <b>y</b> : Stain</p> | <p><b>A</b> : Scratch <b>AU</b> : Scratch &amp; Dent <b>B</b> : Modified <b>C</b> : Corrosion <b>G</b> : Stone chip <b>P</b> : Faded <b>S</b> : Rust <b>SC</b> : Rust &amp; Corrosion <b>U</b> : Dent <b>X</b> : Defective <b>Y</b> : Crack, Gap</p> |
| <p><b>Remarks</b></p> <p>(R) Front Floor Mat - Missing - Yes / (L) Front Floor Mat - Missing - Yes / Mat Other - Missing - Yes / (R) Front Trim - Grime - Medium / Rear Seat - Worn - Yes / (R) Front Seat - Grime - Small / Trunk Room - Worn, Scratch, Cut, Crack - Small / (L) Rear Trim - Grime - Small / (L) Front Trim - Grime - Medium / (L) Front Seat - Grime - Medium / Ceiling - Grime - Small / Dashboard - Traces of Adhesive Tape - Yes</p> | <p><b>Remarks</b></p> <p>(R) Front Door - Repair Traces - Yes / (R) Front Fender - Repair Traces - Yes / (L) Front Door - Repair Traces - Yes / (L) Rear Door - Repair Traces - Yes / (R) Rear Door - Repair Traces - Yes / (R) Rear Door - Repair Traces - Yes / Roof - Repair Traces - Yes / Front Bumper, Grille, Lamps - Crack, Gap - Small / Trunk Hood, Rear Gate - Dent - Minimal / (L) Rear Fender, Molding - Crack, Gap - Small / Rear Bumper, Lamps, Panels - Scratch - Small / (R) Front Door, Molding - Repair mark - Yes / (R) Rear Door, Molding - Repair mark - Yes / (R) Rear Fender, Molding - Repair mark - Yes / (R) Front Fender, Molding - Repair mark - Yes / (L) Rear Door, Molding - Repair mark - Yes / (L) Rear Fender, Molding - Repair mark - Yes / (R) Front Door, Molding - Scratch - Small / (R) Step, In-panel, Side Spoiler - Scratch - Small / (L) Rear Door, Molding - Scratch - Minimal / (L) Front Door, Molding - Scratch - Minimal / Rear Bumper, Lamps, Panels - Repair mark - Difference in Color / Front Bumper, Grille, Lamps - Repair mark - Difference in Color</p> |

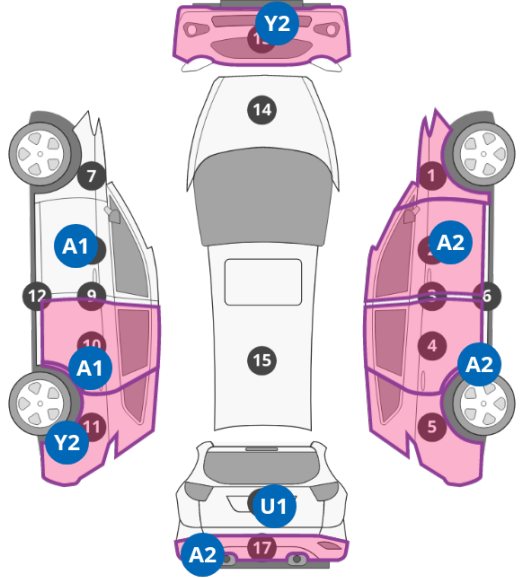
| Inspector Notes |
|---|
| with LTO plate/with spare tire/with jack and incomplete tools/No warranty booklet/front and back bumper difference color |
