## General Information

| Make | Toyota | Model | Vios |
| YOM | 2023 | Mileage | 11,520 |

## Body / Panel Condition

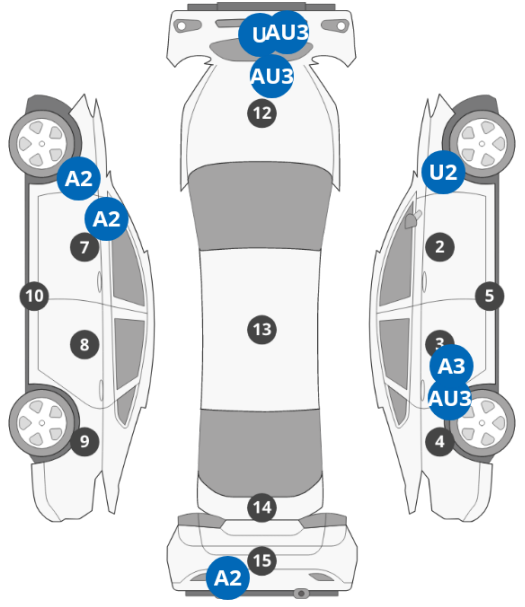
| Interior Evaluation : <span style="color: red;">A</span> | Exterior Evaluation : <span style="color: red;">C</span> |
|---|---|
| <b>Remarks</b><br>Defects not found | <b>Remarks</b><br>Bonnet, Headlight - Scratch & Dent - Medium / Member (Bolted) - Dent - Yes / Front Bumper, Grille, Lamps - Scratch & Dent - Medium / (L) Mirror - Scratch - Small / Rear Bumper, Lamps, Panels - Scratch - Small / (R) Rear Fender, Molding - Scratch & Dent - Medium / (R) Rear Door, Molding - Scratch - Medium / (R) Front Fender, Molding - Dent - Small / (L) Front Fender, Molding - Scratch - Small |

| Inspector Notes |
|---|
| front Toyota emblem loose. swirlmarks and hairline scratches around the exterior. with warranty booklet, user manual and tools. |
