General Information

Make	Mitsubishi	Model	Mirage
YOM	2024	Odo Meter Reading	10,592
Registration No.	NIR9293	Chassis No.	PAEA13TJRPA018128
CC	1.2	Transmission	CVT
Fuel Type	Gas	Type of Body	Sedan
Colour	Red

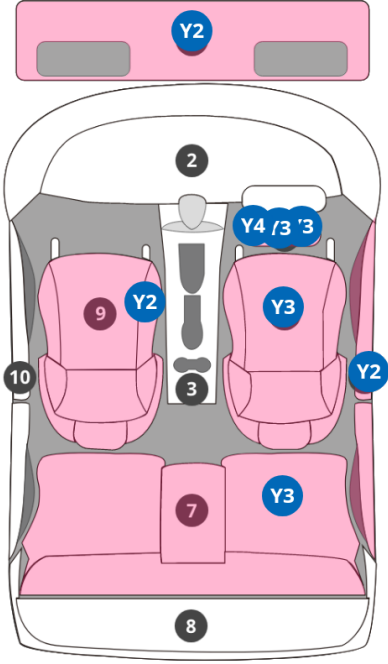
Interior Evaluation : C	Exterior Evaluation : C

<p>a : Cut, Fray d : Loose, Deformed k : Animal Hair s : Smell t : Cigarette Burns x : Defective y : Stain</p>

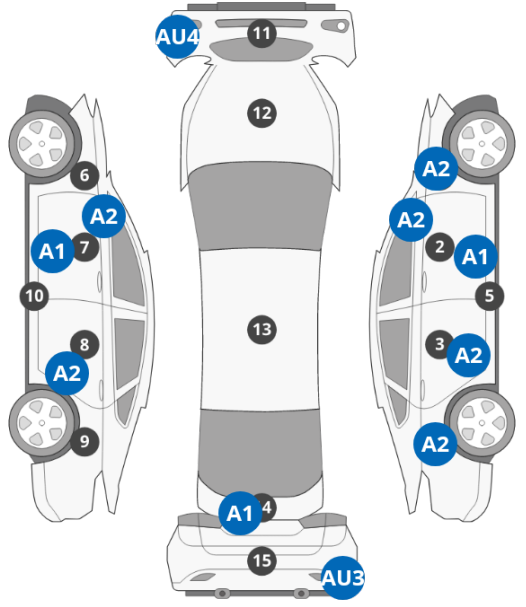
<p>A : Scratch AU : Scratch & Dent B : Modified C : Corrosion G : Stone chip P : Faded S : Rust SC : Rust & Corrosion U : Dent X : Defective Y : Crack, Gap</p>
<p>Remarks Ceiling - Grime - Small / (R) Front Trim - Grime - Small / (R) Front Floor Mat - Grime - Medium / (R) Front Seat - Grime - Medium / Rear Seat - Grime - Medium / Mat Other - Grime - Medium / (L) Front Floor Mat - Grime - Large / (L) Front Seat - Grime - Small</p>	<p>Remarks Bonnet - Repair Traces - Yes / (R) Mirror - Scratch - Small / (R) Front Fender, Molding - Scratch - Small / (R) Front Door, Molding - Scratch - Minimal / (R) Rear Door, Molding - Scratch - Small / (R) Rear Fender, Molding - Scratch - Small / Trunk Hood, Rear Gate - Scratch - Minimal / Rear Bumper, Lamps, Panels - Scratch & Dent - Medium / (L) Rear Door, Molding - Scratch - Small / (L) Mirror - Scratch - Small / (L) Front Door, Molding - Scratch - Minimal / Front Bumper, Grille, Lamps - Scratch & Dent - Large</p>
