General Information

Make	Toyota	Model	Vios
YOM	2023	Odo Meter Reading	21,357
Registration No.	GAP3893	Chassis No.	PA1B18F34N4194607
CC	1.3	Transmission	M/T
Fuel Type	Gas	Type of Body	Sedan
Colour	Blackish Red Mica

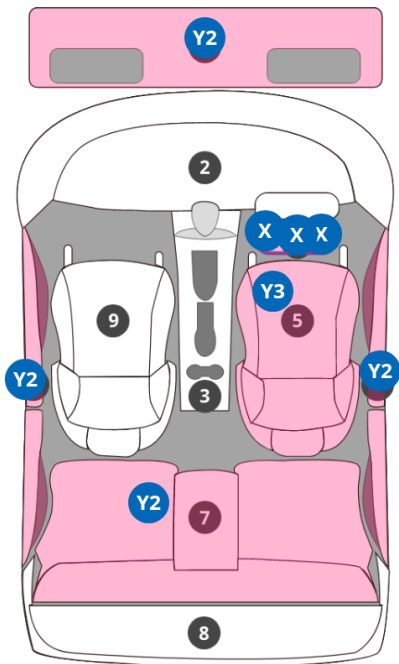
Interior Evaluation : B	Exterior Evaluation : D

<p>a : Cut, Fray d : Loose, Deformed k : Animal Hair s : Smell t : Cigarette Burns x : Defective y : Stain</p>

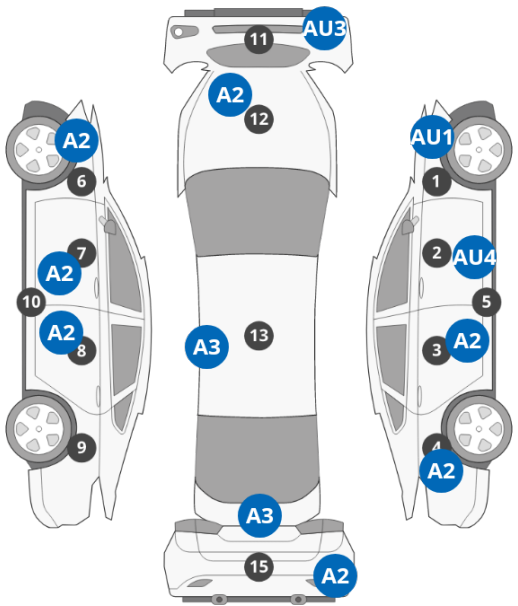
<p>A : Scratch AU : Scratch & Dent B : Modified C : Corrosion G : Stone chip P : Faded S : Rust SC : Rust & Corrosion U : Dent X : Defective Y : Crack, Gap</p>
<p>Remarks Ceiling - Grime - Small / (R) Front Floor Mat - Missing - Yes / Mat Other - Missing - Yes / (L) Front Floor Mat - Missing - Yes / (R) Front Trim - Grime - Small / (R) Front Seat - Grime - Medium / Rear Seat - Grime - Small / (L) Front Trim - Grime - Small</p>	<p>Remarks (L) Front Door, Molding - Scratch - Small / (L) Rear Door, Molding - Scratch - Small / (L) Front Fender, Molding - Scratch - Small / Bonnet, Headlight - Scratch - Small / (R) Front Fender, Molding - Scratch & Dent - Minimal / (R) Front Door, Molding - Scratch & Dent - Large / (R) Rear Door, Molding - Scratch - Small / (R) Rear Fender, Molding - Scratch - Small / Rear Bumper, Lamps, Panels - Scratch - Small / Trunk Hood, Rear Gate - Scratch - Medium / Roof - Scratch - Medium / Front Bumper, Grille, Lamps - Scratch & Dent - Medium</p>
