General Information

Make	Toyota	Model	Vios
YOM	2022	Odo Meter Reading	38,700
Registration No.	NIE1576	Chassis No.	PA1B18F34N4186748
CC	1.3	Transmission	CVT
Fuel Type	Gas	Type of Body	Sedan
Colour	Green

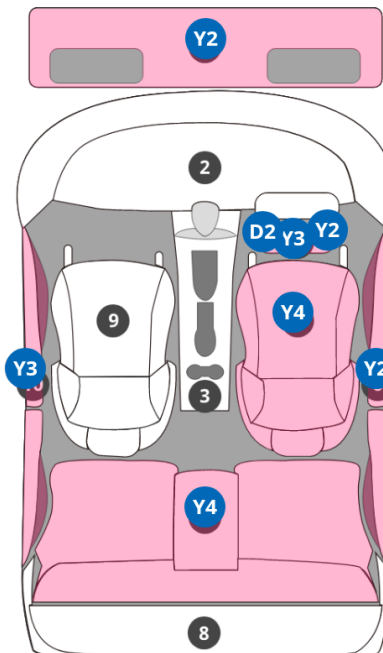
Interior Evaluation : C	Exterior Evaluation : E

<p>a : Cut, Fray d : Loose, Deformed k : Animal Hair s : Smell t : Cigarette Burns x : Defective y : Stain</p>

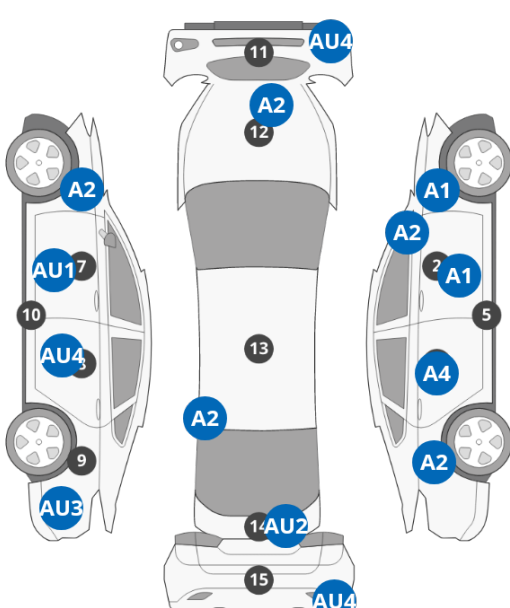
<p>A : Scratch AU : Scratch & Dent B : Modified C : Corrosion G : Stone chip P : Faded S : Rust SC : Rust & Corrosion U : Dent X : Defective Y : Crack, Gap</p>
<p>Remarks Ceiling - Grime - Small / (R) Front Trim - Grime - Small / (R) Front Floor Mat - Grime - Small / (R) Front Seat - Grime - Large / Rear Seat - Grime - Large / Mat Other - Grime - Medium / (L) Front Trim - Grime - Medium / (L) Front Floor Mat - Worked - Small</p>	<p>Remarks (R) Front Fender - Repair Traces - Yes / Rear Bumper, Lamps, Panels - Scratch & Dent - Large / Trunk Hood, Rear Gate - Scratch & Dent - Small / (L) Rear Fender, Molding - Scratch & Dent - Medium / (L) Rear Door, Molding - Scratch & Dent - Large / (L) Front Door, Molding - Scratch & Dent - Minimal / (L) Front Fender, Molding - Scratch - Small / Front Bumper, Grille, Lamps - Scratch & Dent - Large / Bonnet, Headlight - Scratch - Small / (R) Mirror - Scratch - Small / (R) Front Fender, Molding - Scratch - Minimal / (R) Front Door, Molding - Scratch - Minimal / (R) Rear Fender, Molding - Scratch - Small / (R) Rear Door, Molding - Scratch - Large / Roof - Scratch - Small</p>
