General Information

Make	Toyota	Model	Avanza
YOM	2023	Odo Meter Reading	57,604
Registration No.	NIN2218	Chassis No.	MHFAA1BY7P0013725
CC	1.3	Transmission	M/T
Fuel Type	Gas	Type of Body	MPV
Colour	Silver

Body / Panel Condition

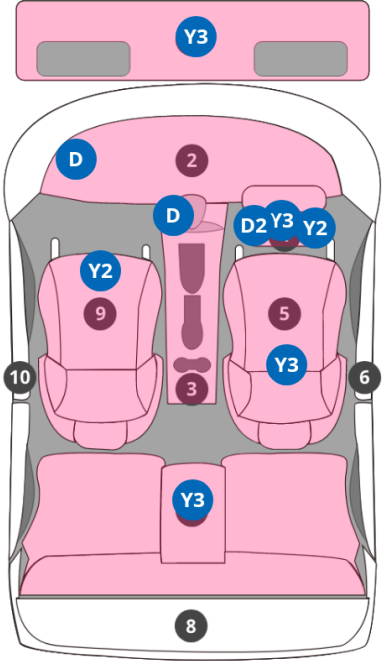
Interior Evaluation : C	Exterior Evaluation : E

<p>a : Cut, Fray d : Loose, Deformed k : Animal Hair s : Smell t : Cigarette Burns x : Defective y : Stain</p>

<p>Inspector Notes</p>
<p>Seats has molds. Adhesive marks at rear view mirror. Without warranty booklet, seat cover and tools. With spare tire and jack. 1 key. With LTO plate.</p>

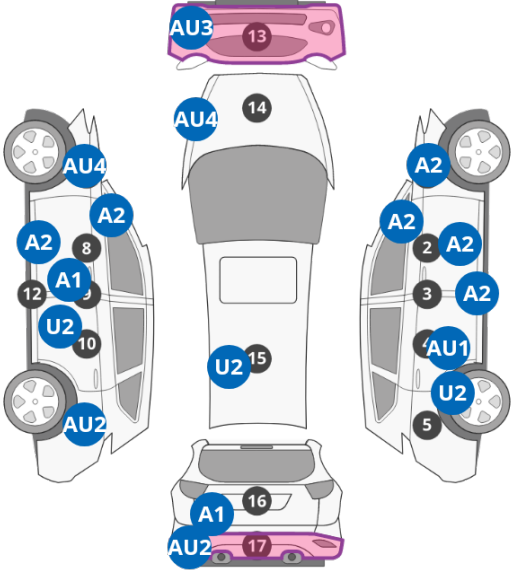
<p>A : Scratch AU : Scratch & Dent B : Modified C : Corrosion G : Stone chip P : Faded S : Rust SC : Rust & Corrosion U : Dent X : Defective Y : Crack, Gap</p>
<p>Remarks Ceiling - Grime - Medium / Console, Switchs, Vents - Traces of Adhesive Tape - Yes / (R) Front Floor Mat - Grime - Small / (R) Front Seat - Grime - Medium / Mat Other - Grime - Medium / Rear Seat - Grime - Medium / (L) Front Seat - Grime - Small / (L) Front Floor Mat - Worked - Small / Dashboard - Traces of Adhesive Tape - Yes</p>	<p>Remarks (L) Rear Fender, Molding - Scratch & Dent - Small / (L) Mirror - Scratch - Small / (L) Step, In-panel, Side Spoiler - Scratch - Small / (L) Front Door, Molding - Scratch - Minimal / (L) Rear Door, Molding - Dent - Small / (L) Front Fender, Molding - Scratch & Dent - Large / Bonnet, Headlight - Scratch & Dent - Large / Front Bumper, Grille, Lamps - Repair mark - Yes / Front Bumper, Grille, Lamps - Scratch & Dent - Medium / (R) Front Fender, Molding - Scratch - Small / (R) Mirror - Scratch - Small / (R) Front Door, Molding - Scratch - Small / (R) Rear Door, Molding - Scratch & Dent - Minimal / (R) Step, In-panel, Side Spoiler - Scratch - Small / (R) Rear Fender, Molding - Dent - Small / Trunk Hood, Rear Gate - Scratch - Minimal / Rear Bumper, Lamps, Panels - Repair mark - Yes / Rear Bumper, Lamps, Panels - Scratch & Dent - Small / Roof - Dent - Small</p>
