General Information

Make	Mitsubishi	Model	Mirage
YOM	2019	Odo Meter Reading	63,037
Registration No.	NDP4992	Chassis No.	PAEA13TXKKA007131
CC	1.2	Transmission	A/T
Fuel Type	Gas	Type of Body	Sedan
Colour	Red

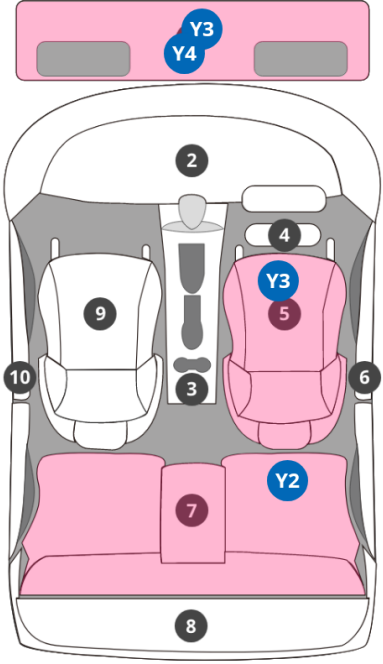
<p>a : Cut, Fray d : Loose, Deformed k : Animal Hair s : Smell t : Cigarette Burns x : Defective y : Stain</p>

<p>A : Scratch AU : Scratch & Dent B : Modified C : Corrosion G : Stone chip P : Faded S : Rust SC : Rust & Corrosion U : Dent X : Defective Y : Crack, Gap</p>
<p>Remarks Ceiling - Grime - Medium / Sunvisor, Sunglass Holder - Grime - Large / (R) Front Seat - Grime - Medium / Rear Seat - Grime - Small</p>	<p>Remarks (R) Front Fender, Molding - Scratch - Minimal / (R) Front Door, Molding - Repair mark - Yes / (R) Front Door, Molding - Scratch - Medium / (R) Rear Door, Molding - Scratch - Small / (R) Rear Fender, Molding - Dent - Small / Trunk Hood, Rear Gate - Scratch - Small / Rear Bumper, Lamps, Panels - Scratch - Medium / (L) Rear Fender, Molding - Scratch - Minimal / (L) Rear Door, Molding - Repair mark - Yes / (L) Rear Door, Molding - Scratch & Dent - Small / (L) Front Door, Molding - Scratch - Small / (L) Mirror - Scratch - Minimal / (L) Front Fender, Molding - Scratch - Small / Bonnet, Headlight - Scratch - Small / Front Bumper, Grille, Lamps - Scratch & Dent - Large</p>

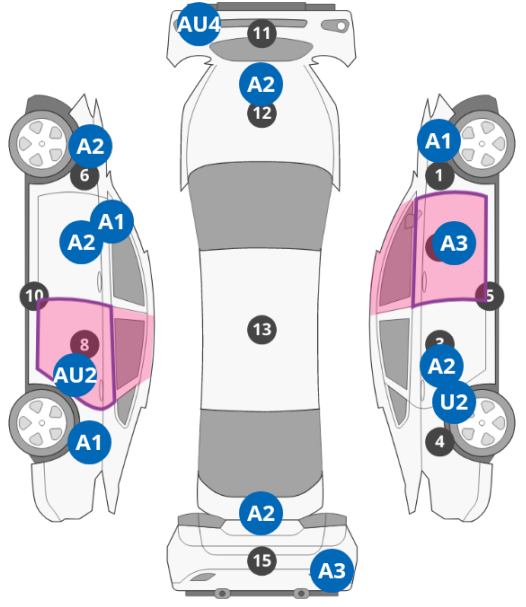
<p>Inspector Notes</p>
<p>Gap at front and rear bumper, Without warranty booklet, jack and tools. With spare tire. 1 key. With LTO plate.</p>
