## General Information

| Make | Toyota | Model | Vios |

## Body / Panel Condition

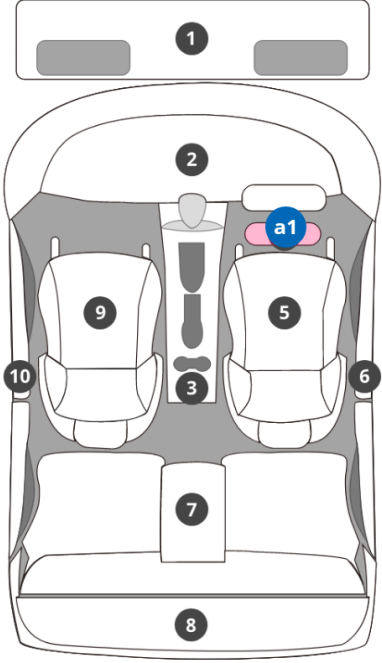
| Interior Evaluation : <b>A</b> | Exterior Evaluation : <b>B</b> |
|---|---|
| <b>Remarks</b><br>(L) Front Floor Mat - Cut, Crack - Minimal | <b>Remarks</b><br>Front Bumper, Grille, Lamps - Scratch - Medium / (L) Front Door, Molding - Scratch - Small / (L) Rear Fender, Molding - Scratch - Small / Rear Bumper, Lamps, Panels - Scratch - Small / (R) Rear Fender, Molding - Scratch - Small / (R) Front Door, Molding - Scratch - Minimal / Bonnet, Headlight - Scratch - Small / Roof - Scratch - Minimal |

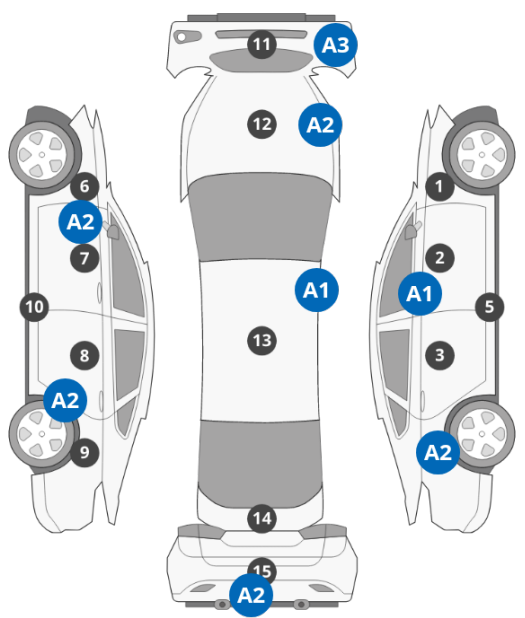
hairline scratches around the exterior. with warranty booklet, user manual and tools. dirt marks at the trunk room.
