General Information

Make	Hyundai	Model	Accent
YOM	2020	Odo Meter Reading	46,039
Registration No.	LAG7447	Chassis No.	PEH841BALH004402
CC	1.4	Transmission	M/T
Fuel Type	Gas	Type of Body	Sedan
Colour	White

Body / Panel Condition

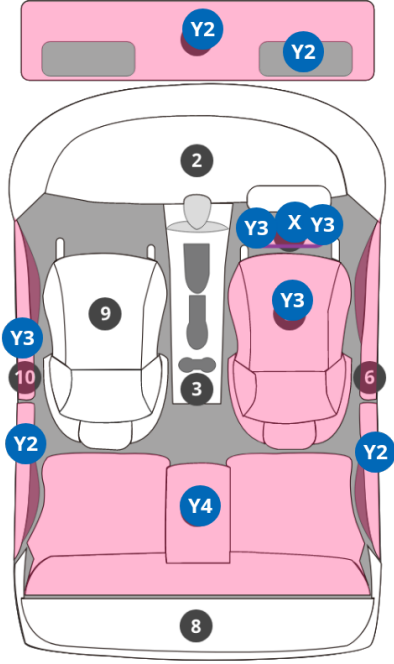
Interior Evaluation : C	Exterior Evaluation : D

<p>a : Cut, Fray d : Loose, Deformed k : Animal Hair s : Smell t : Cigarette Burns x : Defective y : Stain</p>

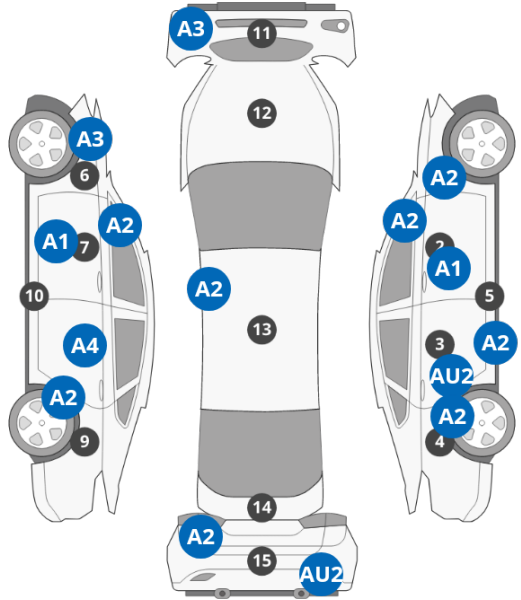
<p>A : Scratch AU : Scratch & Dent B : Modified C : Corrosion G : Stone chip P : Faded S : Rust SC : Rust & Corrosion U : Dent X : Defective Y : Crack, Gap</p>
<p>Remarks Ceiling - Grime - Small / Mat Other - Missing - Yes / (R) Front Floor Mat - Grime - Medium / (R) Front Seat - Grime - Medium / Rear Seat - Grime - Large / (L) Rear Trim - Grime - Small / (R) Rear Trim - Grime - Small / (L) Front Trim - Grime - Medium / (L) Front Floor Mat - Grime - Medium / Sunvisor, Sunglass Holder - Grime - Small</p>	<p>Remarks Bonnet - Repair Traces - Yes / (L) Front Door - Repair Traces - Yes / (L) Rear Door, Molding - Scratch - Large / (L) Mirror - Scratch - Small / (L) Front Door, Molding - Scratch - Minimal / (L) Rear Fender, Molding - Scratch - Small / (L) Front Fender, Molding - Scratch - Medium / Front Bumper, Grille, Lamps - Scratch - Medium / (R) Mirror - Scratch - Small / (R) Front Fender, Molding - Scratch - Small / (R) Front Door, Molding - Scratch - Minimal / (R) Step, In-panel, Side Spoiler - Scratch - Small / (R) Rear Door, Molding - Scratch & Dent - Small / (R) Rear Fender, Molding - Scratch - Small / Rear Bumper, Lamps, Panels - Scratch & Dent - Small / Trunk Hood, Rear Gate - Scratch - Small / Roof - Scratch - Small</p>
