## General Information

| Make | Toyota | Model | Hiace |
| Registration No. | DAU7720 | Chassis No. | JTFJT02P5M5026373 |

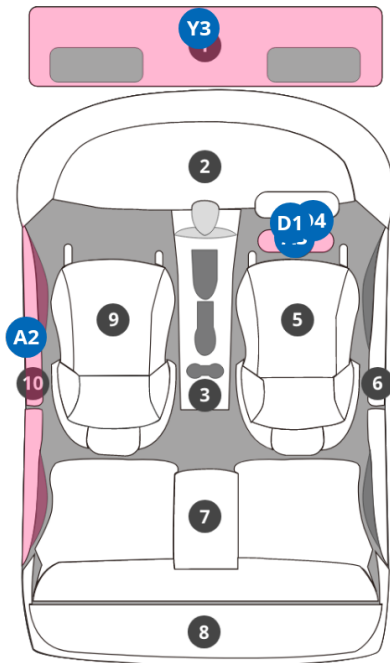
| Interior Evaluation : <b>C</b> | Exterior Evaluation : <b>D</b> |
|---|---|
| <p><b>Remarks</b></p> <p>Overall Interior - Worn as per age - Yes / Ceiling - Grime - Medium / (L) Front Floor Mat - Cut, Crack - Medium / (L) Front Floor Mat - Worked - Large / Carpet - Worked - Minimal / (L) Front Trim - Cut, Crack - Small</p> | <p><b>Remarks</b></p> <p>(L) Rear Fender - Repair Traces - Yes / Trunk Hood, Rear Gate - Repair Traces - Yes / (R) Front Door, Molding - Scratch &amp; Dent - Medium / (R) Front Fender, Molding - Scratch - Small / (R) Mirror - Scratch - Minimal / (R) Center Panel - Scratch - Small / (R) Rear Door, Molding - Scratch &amp; Dent - Large / (R) Rear Fender, Molding - Scratch - Small / Rear Bumper, Lamps, Panels - Scratch &amp; Dent - Medium / Trunk Hood, Rear Gate - Scratch - Small / (L) Rear Fender, Molding - Scratch - Small / (L) Rear Door, Molding - Scratch - Minimal / (L) Front Door, Molding - Scratch - Small / (L) Mirror - Scratch - Minimal / Front Bumper, Grille, Lamps - Scratch - Medium / Front Panel - Scratch - Minimal / Roof - Scratch - Minimal</p> |
