## General Information

| Make | Toyota | Model | Wigo |

## Body / Panel Condition

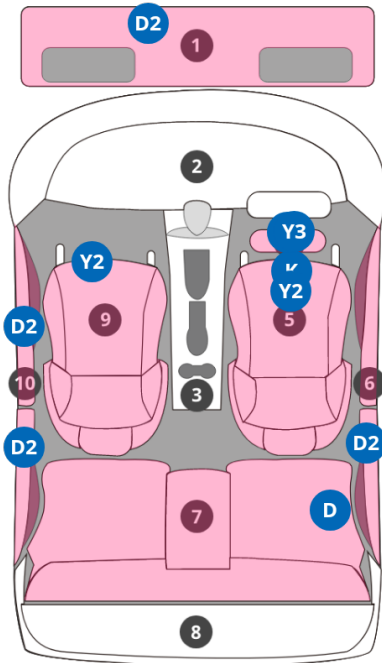
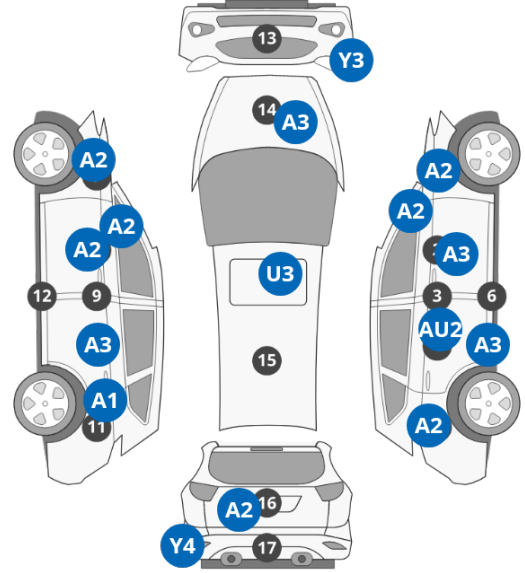
| Interior Evaluation : <span style="color: red;">C</span> | Exterior Evaluation : <span style="color: red;">E</span> |
|---|---|
| <p><b>a</b> : Cut, Fray <b>d</b> : Loose, Deformed <b>k</b> : Animal Hair <b>s</b> : Smell <b>t</b> : Cigarette Burns <b>x</b> : Defective <b>y</b> : Stain</p> | <p><b>A</b> : Scratch <b>AU</b> : Scratch &amp; Dent <b>B</b> : Modified <b>C</b> : Corrosion <b>G</b> : Stone chip <b>P</b> : Faded <b>S</b> : Rust <b>SC</b> : Rust &amp; Corrosion <b>U</b> : Dent <b>X</b> : Defective <b>Y</b> : Crack, Gap</p> |
| <b>Remarks</b><br>Overall Interior - Animal Hair - Yes / (R) Front Seat - Grime - Small / Rear Seat - Worn - Yes / (R) Front Trim - Worked - Small / (L) Front Seat - Grime - Small / Mat Other - Grime - Small / (R) Front Floor Mat - Grime - Medium / (L) Front Trim - Worked - Small / (L) Rear Trim - Worked - Small / Ceiling - Crinkle - Small | <b>Remarks</b><br>(R) Front Fender, Molding - Scratch - Small / (R) Mirror - Scratch - Small / (R) Front Door, Molding - Scratch - Medium / (R) Step, In-panel, Side Spoiler - Scratch - Medium / (R) Rear Door, Molding - Scratch & Dent - Small / (R) Rear Fender, Molding - Scratch - Small / Rear Bumper, Lamps, Panels - Crack, Gap - Large / Trunk Hood, Rear Gate - Scratch - Small / (L) Rear Fender, Molding - Scratch - Minimal / (L) Rear Door, Molding - Scratch - Medium / (L) Mirror - Scratch - Small / (L) Front Door, Molding - Scratch - Small / (L) Front Fender, Molding - Scratch - Small / Front Bumper, Grille, Lamps - Crack, Gap - Medium / Bonnet, Headlight - Scratch - Medium / Roof - Dent - Medium |
