## General Information

| Make | Toyota | Model | Vios |
| Registration No. | NFR2129 | Chassis No. | PA1B18F3XR4248353 |

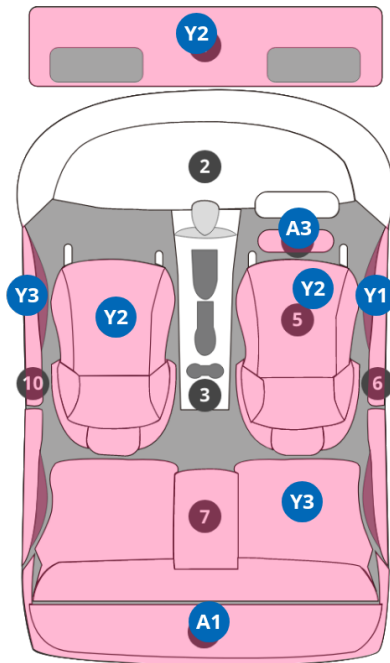
| Interior Evaluation : <span style="color: red;">C</span> | Exterior Evaluation : <span style="color: red;">B</span> |
|---|---|
| <b>Remarks</b><br>Rear Seat - Grime - Medium / (R) Front Seat - Grime - Small / (R) Front Trim - Grime - Minimal / (L) Front Seat - Grime - Small / (L) Front Floor Mat - Cut, Crack - Medium / Ceiling - Grime - Small / Trunk Room - Worn, Scratch, Cut, Crack - Minimal / (L) Front Trim - Grime - Medium | <b>Remarks</b><br>(L) Rear Fender, Molding - Dent - Small / (R) Rear Fender, Molding - Scratch - Minimal / Rear Bumper, Lamps, Panels - Scratch - Small / (L) Front Fender, Molding - Scratch - Minimal / (L) Mirror - Scratch - Minimal / (L) Front Door, Molding - Scratch - Minimal / (R) Rear Door, Molding - Scratch - Minimal / Front Bumper, Grille, Lamps - Scratch - Small |
