General Information

Make	Nissan	Model	NV350
YOM	2020	Odo Meter Reading	98,109
Registration No.	NGP2861	Chassis No.	JN1TC2E26Z0062324
CC	2.5	Transmission	M/T
Fuel Type	Diesel	Type of Body	Van
Colour	White

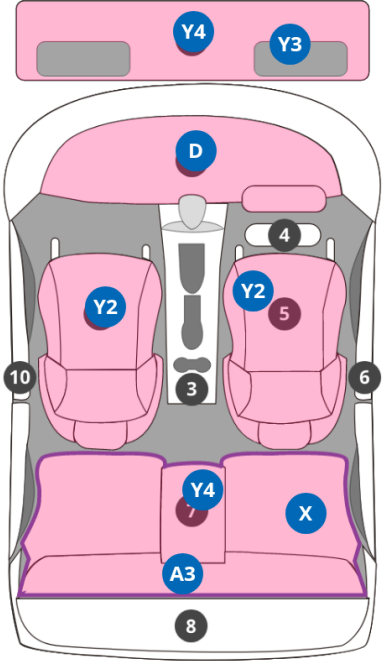
Interior Evaluation : C	Exterior Evaluation : E

<p>a : Cut, Fray d : Loose, Deformed k : Animal Hair s : Smell t : Cigarette Burns x : Defective y : Stain</p>

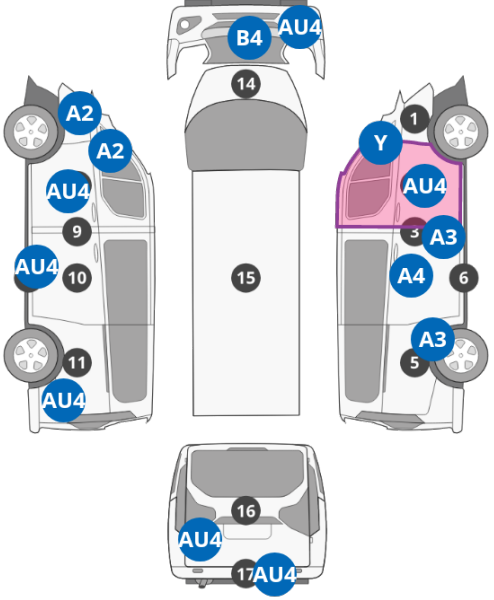
<p>A : Scratch AU : Scratch & Dent B : Modified C : Corrosion G : Stone chip P : Faded S : Rust SC : Rust & Corrosion U : Dent X : Defective Y : Crack, Gap</p>
<p>Remarks Ceiling - Grime - Large / Sunvisor, Sunglass Holder - Grime - Medium / Dashboard - Traces of Adhesive Tape - Yes / (R) Front Seat - Grime - Small / Rear Seat Head Rest - Worn, Peel, Cut - Medium / Rear Seat - Grime - Large / Rear Seat - Partially Missing - Yes / (L) Front Seat - Grime - Small</p>	<p>Remarks (L) Rear Fender, Molding - Scratch & Dent - Large / (L) Step, In-panel, Side Spoiler - Scratch & Dent - Large / (L) Front Door, Molding - Scratch & Dent - Large / (L) Front Fender, Molding - Scratch - Small / Front Bumper, Grille, Lamps - Scratch & Dent - Large / Front Bumper, Grille, Lamps - Modified - Large / (R) Mirror - Crack - Damaged / (R) Front Door, Molding - Scratch & Dent - Large / (R) Front Door, Molding - Repair mark - Yes / (R) Center Panel - Scratch - Medium / (R) Rear Door, Molding - Scratch - Large / (R) Rear Fender, Molding - Scratch - Medium / Trunk Hood, Rear Gate - Scratch & Dent - Large / Rear Bumper, Lamps, Panels - Scratch & Dent - Large / (L) Mirror - Scratch - Small</p>
