## General Information

| Make | Mitsubishi | Model | Mirage |
| Registration No. | DBH3980 | Chassis No. | PAEA13RXPPA015287 |

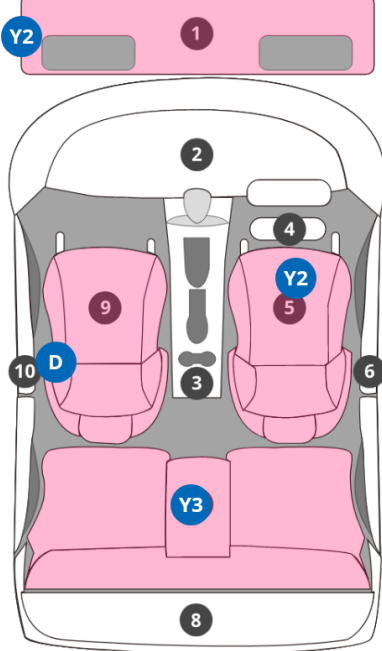
| Interior Evaluation : <b>B</b> | Exterior Evaluation : <b>C</b> |
| <p><b>Remarks</b><br/>(L) Front Seat - Worn - Yes / (R) Front Seat - Grime - Small / Rear Seat - Grime - Medium / Ceiling - Grime - Small</p> | <p><b>Remarks</b><br/>(L) Rear Door - Repair Traces - Yes / (L) Rear Fender - Repair Traces - Yes / Trunk Hood, Rear Gate - Repair Traces - Yes / (R) Front Fender, Molding - Scratch - Small / (R) Mirror - Scratch - Minimal / (R) Front Door, Molding - Scratch - Small / (R) Rear Door, Molding - Scratch - Small / (R) Rear Fender, Molding - Scratch - Minimal / Rear Bumper, Lamps, Panels - Scratch &amp; Dent - Small / Trunk Hood, Rear Gate - Scratch - Minimal / (L) Rear Fender, Molding - Scratch - Small / (L) Rear Door, Molding - Scratch - Small / (L) Front Door, Molding - Scratch - Small / (L) Mirror - Scratch - Minimal / (L) Front Fender, Molding - Scratch - Minimal / Front Bumper, Grille, Lamps - Crack, Gap - Medium / Bonnet, Headlight - Crack, Gap - Large / Roof - Scratch - Small</p> |

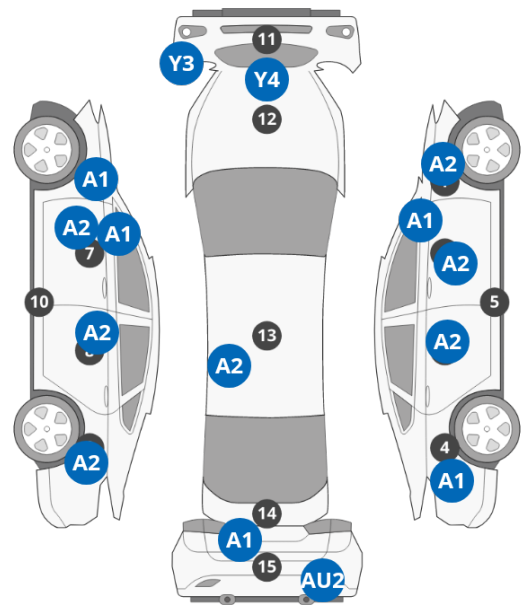
| Inspector Notes |
|---|
| with warranty booklet, with jack and tools, with spare tire, with LTO plate, scratches on headlight and tail light |
