General Information

Make	Toyota	Model	Vios
YOM	2024	Odo Meter Reading	11,831
Registration No.	IAF6847	Chassis No.	PA1B18F38R4260016
CC	1.3	Transmission	CVT
Fuel Type	Gas	Type of Body	Sedan
Colour	Red Mica Metallic

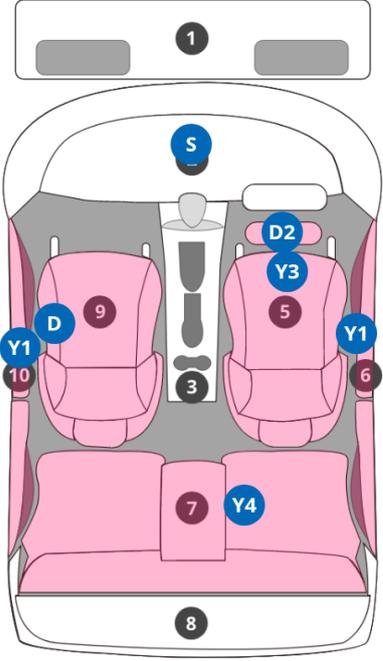
<p>a : Cut, Fray d : Loose, Deformed k : Animal Hair s : Smell t : Cigarette Burns x : Defective y : Stain</p>

<p>A : Scratch AU : Scratch & Dent B : Modified C : Corrosion G : Stone chip P : Faded S : Rust SC : Rust & Corrosion U : Dent X : Defective Y : Crack, Gap</p>
<p>Remarks Rear Seat - Grime - Large / Overall Interior - Smell - Yes / (R) Front Trim - Grime - Minimal / (R) Front Seat - Grime - Medium / (L) Front Seat - Worn - Yes / (L) Front Trim - Grime - Minimal / (L) Front Floor Mat - Worked - Small</p>	<p>Remarks (R) Front Fender, Molding - Scratch - Minimal / (R) Mirror - Scratch - Small / (R) Front Door, Molding - Scratch - Medium / (R) Rear Door, Molding - Scratch - Minimal / (R) Rear Fender, Molding - Dent - Minimal / Rear Bumper, Lamps, Panels - Scratch - Medium / Trunk Hood, Rear Gate - Scratch - Minimal / (L) Rear Fender, Molding - Scratch - Small / (L) Rear Door, Molding - Scratch - Minimal / (L) Front Door, Molding - Scratch - Minimal / (L) Front Fender, Molding - Scratch & Dent - Minimal / Front Bumper, Grille, Lamps - Scratch - Small / Bonnet, Headlight - Scratch - Minimal</p>
