General Information

Make	Mercedes-Benz	Model	GLC 200
YOM	2018	Odo Meter Reading	22,250
Registration No.	NCU5846	Chassis No.	WOC2523421F413C44
CC	2.0	Transmission	A/T
Fuel Type	Gas	Type of Body	Wagon
Colour	Gray

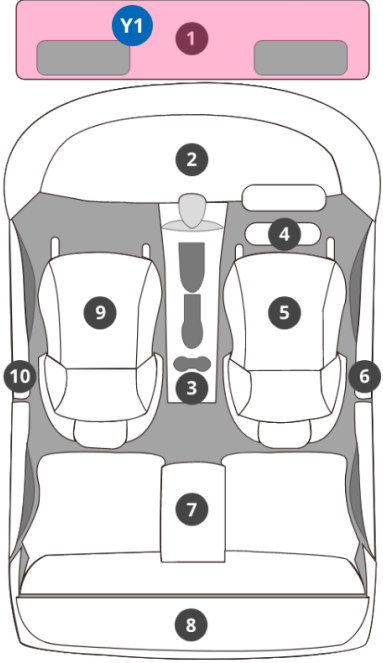
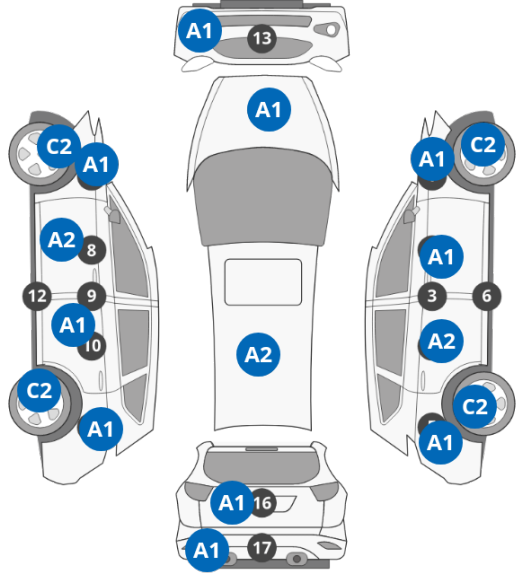
Interior Evaluation :	A	Exterior Evaluation :	B

<p>a : Cut, Fray d : Loose, Deformed k : Animal Hair s : Smell t : Cigarette Burns x : Defective y : Stain</p>		<p>A : Scratch AU : Scratch & Dent B : Modified C : Corrosion G : Stone chip P : Faded S : Rust SC : Rust & Corrosion U : Dent X : Defective Y : Crack, Gap</p>	
<p>Remarks Ceiling - Grime - Minimal</p>		<p>Remarks Rear Bumper, Lamps, Panels - Scratch - Minimal / Trunk Hood, Rear Gate - Scratch - Minimal / (L) Rear Fender, Molding - Scratch - Minimal / (L) Rear Door, Molding - Scratch - Minimal / (L) Front Door, Molding - Scratch - Small / (L) Front Fender, Molding - Scratch - Minimal / Front Bumper, Grille, Lamps - Scratch - Minimal / Bonnet, Headlight - Scratch - Minimal / (R) Front Fender, Molding - Scratch - Minimal / (R) Front Door, Molding - Scratch - Minimal / (R) Rear Door, Molding - Scratch - Small / (R) Rear Fender, Molding - Scratch - Minimal / Roof - Scratch - Small / (R) Front Wheel, Cover - Scratch, Corrosion - Small / (R) Rear Wheel, Cover - Scratch, Corrosion - Small / (L) Rear Wheel, Cover - Scratch, Corrosion - Small / (L) Front Wheel, Cover - Scratch, Corrosion - Small</p>
