## General Information

| Make | Nissan | Model | Navara |
| Registration No. | KAF8630-1 | Chassis No. | MNTCC2D23Z087001 |

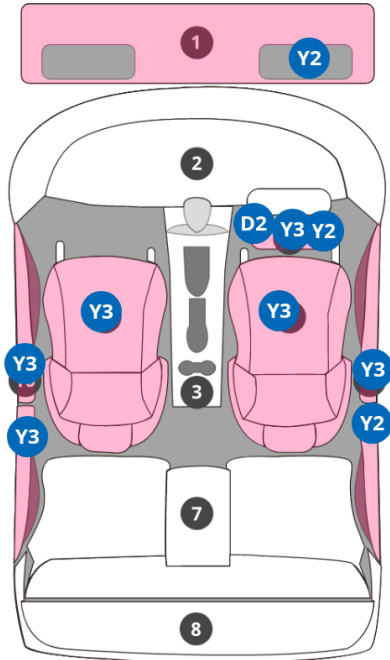
| Interior Evaluation : <span style="color: red;">D</span> | Exterior Evaluation : <span style="color: red;">E</span> |
|---|---|
| <p><b>Remarks</b></p> <p>(R) Front Trim - Grime - Medium / (R) Rear Trim - Grime - Small / (R) Front Seat - Grime - Medium / (L) Front Seat - Grime - Medium / (R) Front Floor Mat - Grime - Small / Mat Other - Grime - Medium / (L) Front Floor Mat - Worked - Small / (L) Front Trim - Grime - Medium / (L) Rear Trim - Grime - Medium / Sunvisor, Sunglass Holder - Grime - Small</p> | <p><b>Remarks</b></p> <p>(R) Front Fender - Repair Traces - Yes / Rear Bumper, Lamps, Panels - Scratch &amp; Dent - Medium / Rear Gate - Scratch &amp; Dent - Large / (L) Side Gate - Scratch &amp; Dent - Medium / (L) Rear Door, Molding - Scratch &amp; Dent - Large / (L) Front Door, Molding - Scratch &amp; Dent - Large / (L) Front Fender, Molding - Scratch &amp; Dent - Medium / (L) Rear Corner Panel - Scratch - Medium / Front Bumper, Grille, Lamps - Scratch &amp; Dent - Large / Front Bumper, Grille, Lamps - Repair mark - Yes / (L) Front Door, Molding - Repair mark - Yes / (R) Side Gate - Repair mark - Yes / (R) Rear Door, Molding - Repair mark - Yes / (R) Side Gate - Scratch &amp; Dent - Medium / (R) Rear Door, Molding - Scratch &amp; Dent - Large / (R) Front Door, Molding - Scratch &amp; Dent - Large / (R) Front Fender, Molding - Scratch &amp; Dent - Medium / Cab Back Panel - Scratch - Small / Roof - Scratch &amp; Dent - Large / Roof - Modified - Medium / (L) Mirror - Scratch - Minimal / (L) Side Gate - Repair mark - Yes / Bonnet, Headlight - Scratch &amp; Dent - Large / (R) Rear Corner Panel - Scratch - Small</p> |
