## General Information

| Make | Toyota | Model | Vios |

## Overall Evaluation :

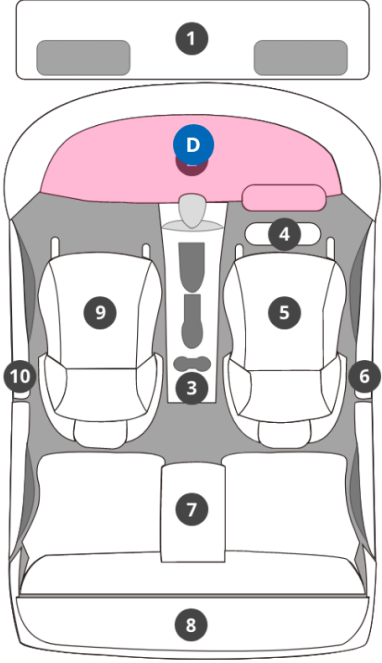
| Interior Evaluation : <span style="color: red; font-weight: bold;">A</span> | Exterior Evaluation : <span style="color: red; font-weight: bold;">D</span> |
|---|---|
| <b>Remarks</b><br>Dashboard - Traces of Adhesive Tape - Yes | <b>Remarks</b><br>(R) Front Fender, Molding - Scratch & Dent - Large / Rear Bumper, Lamps, Panels - Scratch & Dent - Large / (L) Rear Fender, Molding - Scratch - Minimal / (L) Front Door, Molding - Scratch & Dent - Small / (L) Mirror - Scratch - Minimal / Front Bumper, Grille, Lamps - Scratch & Dent - Large / (L) Front Fender, Molding - Scratch - Small / (R) Mirror - Scratch, Peeled - Minimal / (R) Rear Door, Molding - Scratch - Large / (R) Front Door, Molding - Scratch - Small |

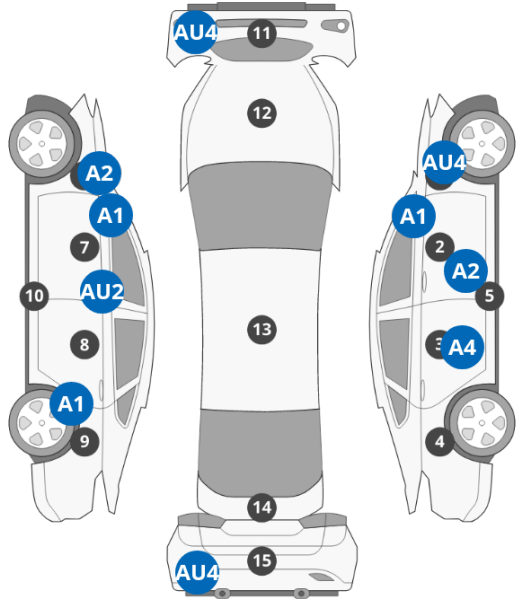
| Inspector Notes |
|---|
| with lto plate,with jack and tools, with spare tire, with seat cover, 1 key,no warranty booklet,gap at right front fender and right front door |
