## General Information

| Make | Toyota | Model | Vios |
| Registration No. | NJA1109 | Chassis No. | PA1B18F34R4274060 |

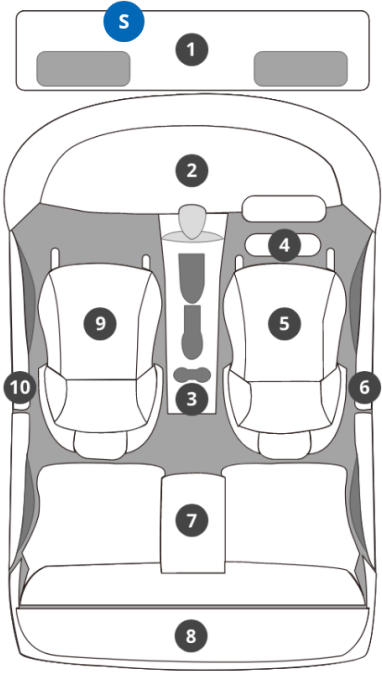
| Interior Evaluation : <b>B</b> | Exterior Evaluation : <b>B</b> |
|---|---|
| <b>Remarks</b><br>Overall Interior - Smell - Yes | <b>Remarks</b><br>(L) Front Door, Molding - Scratch - Minimal / (L) Rear Door, Molding - Scratch - Minimal / (L) Rear Fender, Molding - Scratch - Small / Trunk Hood, Rear Gate - Scratch & Dent - Small / Rear Bumper, Lamps, Panels - Scratch & Dent - Minimal / (R) Rear Fender, Molding - Scratch - Small / (R) Rear Door, Molding - Scratch - Small / (R) Front Door, Molding - Scratch - Minimal / (R) Front Fender, Molding - Scratch - Minimal / (L) Front Fender, Molding - Scratch - Minimal / Roof - Scratch - Minimal / Bonnet, Headlight - Scratch - Small / Front Bumper, Grille, Lamps - Scratch - Small |
