## General Information

| Make | Toyota | Model | Vios |
| YOM | 2024 | Odo Meter Reading | 17,519 |
| Registration No. | DBO1142 | Chassis No. | PA1B18F37P4236402 |

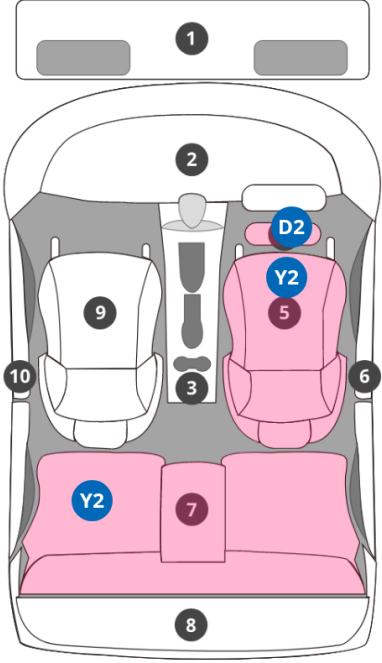
| Interior Evaluation : <b>A</b> | Exterior Evaluation : <b>D</b> |
|---|---|
| <b>Remarks</b><br>Rear Seat - Grime - Small / (L) Front Floor Mat - Worked - Small / (R) Front Seat - Grime - Small | <b>Remarks</b><br>(R) Rear Fender, Molding - Scratch & Dent - Large / (L) Rear Fender, Molding - Scratch - Medium / (L) Rear Door, Molding - Scratch & Dent - Small / (L) Front Door, Molding - Scratch - Small / (L) Front Fender, Molding - Scratch & Dent - Small / Member (Bolted) - Dent - Yes / (L) Step, In-panel, Side Spoiler - Scratch & Dent - Small / (R) Step, In-panel, Side Spoiler - Scratch & Dent - Small / Trunk Hood, Rear Gate - Scratch - Small / Rear Bumper, Lamps, Panels - Scratch - Small / (R) Rear Door, Molding - Scratch - Small / (R) Front Door, Molding - Scratch - Minimal / (R) Front Fender, Molding - Scratch - Minimal / Bonnet, Headlight - Scratch - Small / Roof - Scratch & Dent - Small / Front Bumper, Grille, Lamps - Scratch - Small |

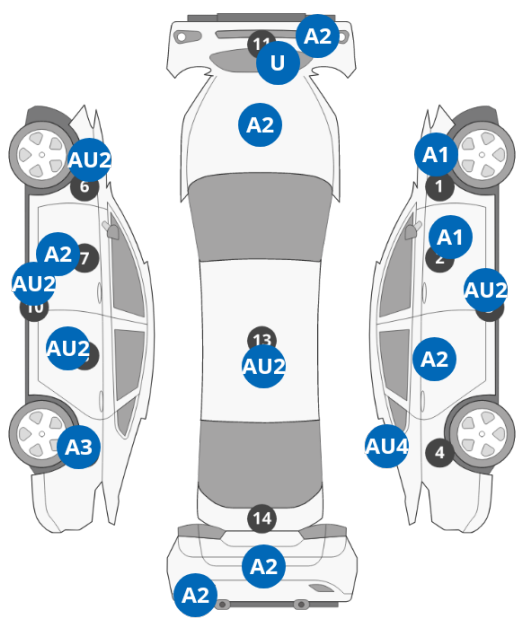
| Inspector Notes |
|---|
| With LTO plate and Spare tire and Warranty, Jack and Incomplete Tools. Crack tail light and scratch headlight and tail light. |
