## General Information

| Make | Toyota | Model | Vios |
| YOM | 2024 | Odo Meter Reading | 18,041 |
| Registration No. | NEY2860 | Chassis No. | PA1B18F34R4251894 |

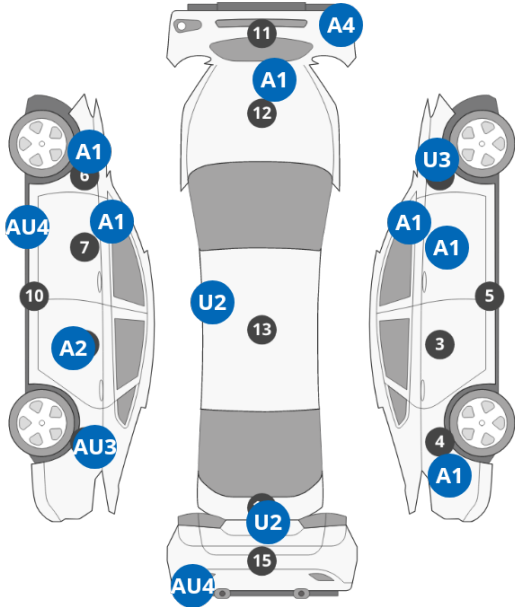
| Interior Evaluation : <span style="color: red;">C</span> | Exterior Evaluation : <span style="color: red;">D</span> |
|---|---|
| <b>Remarks</b><br>(R) Front Seat - Grime - Medium / Dashboard - Traces of Adhesive Tape - Yes / Trunk Room - Worn, Scratch, Cut, Crack - Small / Rear Seat - Grime - Medium / (L) Front Seat - Grime - Medium / (L) Front Trim - Grime - Small / (L) Front Floor Mat - Grime - Medium / Ceiling - Grime - Small | <b>Remarks</b><br>(L) Rear Fender, Molding - Scratch & Dent - Medium / (L) Rear Door, Molding - Scratch - Small / (L) Step, In-panel, Side Spoiler - Scratch & Dent - Large / (L) Mirror - Scratch - Minimal / (L) Front Fender, Molding - Scratch - Minimal / Front Bumper, Grille, Lamps - Scratch - Large / (R) Front Fender, Molding - Dent - Medium / (R) Front Door, Molding - Scratch - Minimal / (R) Rear Fender, Molding - Scratch - Minimal / Trunk Hood, Rear Gate - Dent - Small / Rear Bumper, Lamps, Panels - Scratch & Dent - Large / Roof - Dent - Small / (R) Mirror - Scratch - Minimal / Bonnet, Headlight - Scratch - Minimal |

| Inspector Notes |
|---|
| with LTO plate/with spare tire/with jack and incomplete tools/left side tail light cover small cack/with warranty booklet/left side mirror issue/rear seat carpet dirty / |
