## General Information

| Make | Toyota | Model | Vios |
| YOM | 2024 | Odo Meter Reading | 4,836 |

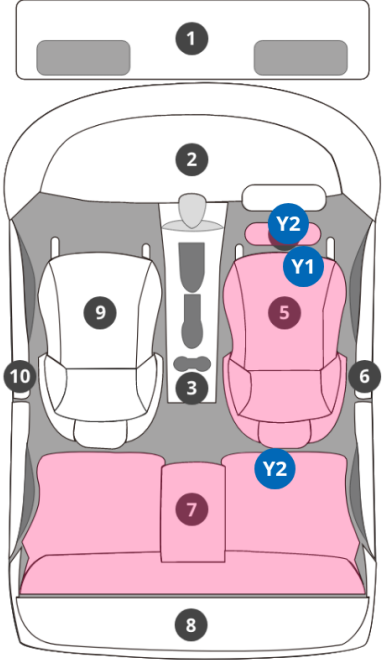
| Interior Evaluation : <b>A</b> | Exterior Evaluation : <b>C</b> |
|---|---|
| <p><b>Remarks</b><br/>Rear Seat - Grime - Small / (R) Front Floor Mat - Grime - Small / (R) Front Seat - Grime - Minimal</p> | <p><b>Remarks</b><br/>(R) Front Fender, Molding - Scratch - Small / (R) Front Door, Molding - Scratch &amp; Dent - Small / (R) Rear Door, Molding - Scratch - Minimal / (R) Rear Fender, Molding - Scratch - Small / Rear Bumper, Lamps, Panels - Scratch - Minimal / Trunk Hood, Rear Gate - Scratch - Minimal / (L) Rear Fender, Molding - Scratch - Minimal / (L) Rear Door, Molding - Scratch - Small / (L) Front Door, Molding - Scratch - Minimal / (L) Front Fender, Molding - Scratch - Small / Front Bumper, Grille, Lamps - Scratch - Small / Roof - Scratch - Medium / Bonnet, Headlight - Scratch - Minimal / (L) Rear Wheel, Cover - Scratch, Corrosion - Small / (R) Rear Wheel, Cover - Scratch, Corrosion - Small / (R) Front Wheel, Cover - Scratch, Corrosion - Small</p> |
