## General Information

| Make | Toyota | Model | Vios |
| Registration No. | NEY8309 | Chassis No. | PA1B18F32R4265857 |

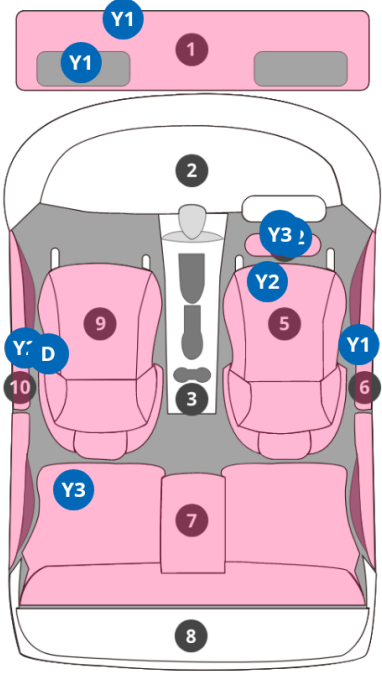
| Interior Evaluation : <b>C</b> | Exterior Evaluation : <b>E</b> |
|---|---|
| <p><b>Remarks</b><br/>(L) Front Floor Mat - Cut, Crack - Small / Rear Seat - Grime - Medium / (R) Front Seat - Grime - Small / (R) Front Floor Mat - Grime - Medium / (L) Front Trim - Grime - Small / (R) Front Trim - Grime - Minimal / (L) Front Seat - Worn - Yes / Sunvisor, Sunglass Holder - Grime - Minimal / Ceiling - Grime - Minimal / Mat Other - Grime - Medium</p> | <p><b>Remarks</b><br/>(L) Rear Fender - Repair Traces - Yes / (R) Front Fender, Molding - Scratch &amp; Dent - Small / (R) Mirror - Scratch - Minimal / (R) Rear Door, Molding - Scratch &amp; Dent - Medium / (R) Front Fender, Molding - Scratch &amp; Dent - Medium / (R) Front Door, Molding - Scratch &amp; Dent - Medium / Rear Bumper, Lamps, Panels - Scratch - Small / Trunk Hood, Rear Gate - Scratch - Small / (L) Front Fender, Molding - Repair mark - Yes / (L) Front Fender, Molding - Scratch &amp; Dent - Small / (L) Mirror - Scratch - Small / (L) Rear Door, Molding - Scratch - Small / (L) Front Door, Molding - Scratch - Minimal / Front Bumper, Grille, Lamps - Repair mark - Yes / Front Bumper, Grille, Lamps - Scratch - Large / Bonnet, Headlight - Scratch - Small / Roof - Scratch - Minimal</p> |

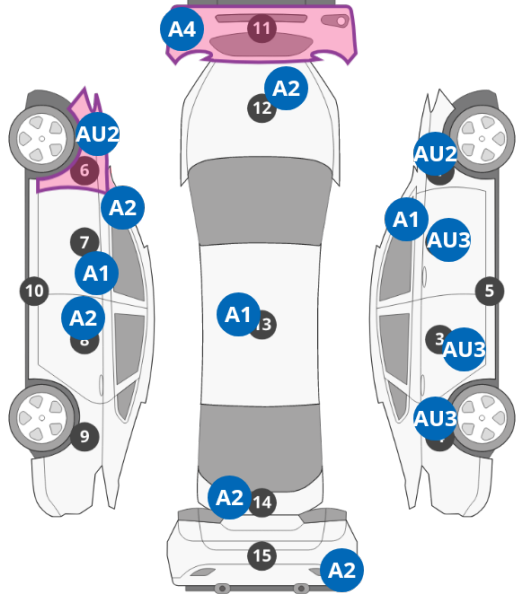
| Inspector Notes |
|---|
| with warranty booklet, with jack, incomplete tools, with spare tire, with LTO plate, scratches on tail light, cheek light issue |
