General Information

Make	Toyota	Model	Vios
YOM	2025	Odo Meter Reading	14,393
Registration No.	NKJ9340	Chassis No.	PA1B18F38R4266172
CC	1.3	Transmission	CVT
Fuel Type	Gas	Type of Body	Sedan
Colour	Black

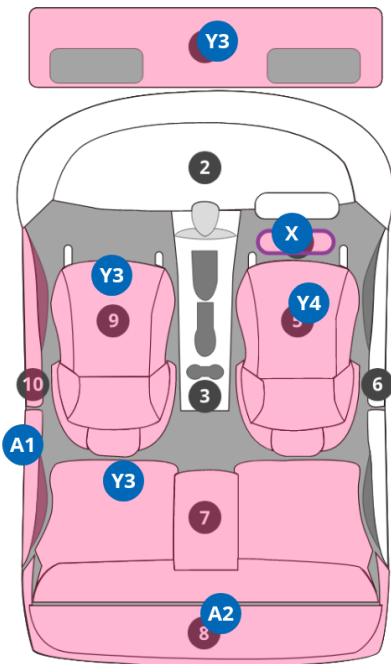
Interior Evaluation : C	Exterior Evaluation : C

<p>a : Cut, Fray d : Loose, Deformed k : Animal Hair s : Smell t : Cigarette Burns x : Defective y : Stain</p>

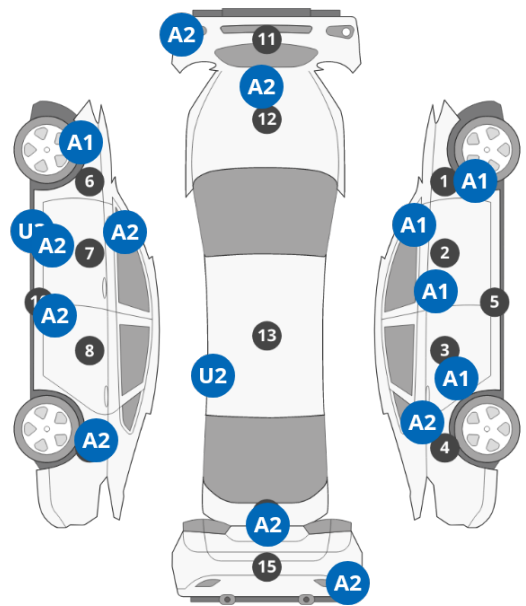
<p>A : Scratch AU : Scratch & Dent B : Modified C : Corrosion G : Stone chip P : Faded S : Rust SC : Rust & Corrosion U : Dent X : Defective Y : Crack, Gap</p>
<p>Remarks Trunk Room - Worn, Scratch, Cut, Crack - Small / (L) Rear Trim - Cut, Crack - Minimal / Rear Seat - Grime - Medium / Ceiling - Grime - Medium / (R) Front Floor Mat - Missing - Yes / (R) Front Seat - Grime - Large / (L) Front Seat - Grime - Medium</p>	<p>Remarks (R) Front Fender, Molding - Scratch - Minimal / (R) Mirror - Scratch - Minimal / (R) Front Door, Molding - Scratch - Minimal / (R) Rear Door, Molding - Scratch - Minimal / (R) Rear Fender, Molding - Scratch - Small / Trunk Hood, Rear Gate - Scratch - Small / Rear Bumper, Lamps, Panels - Scratch - Small / Roof - Dent - Small / (L) Rear Fender, Molding - Scratch - Small / (L) Rear Door, Molding - Scratch - Small / (L) Step, In-panel, Side Spoiler - Dent - Medium / (L) Front Door, Molding - Scratch - Small / (L) Mirror - Scratch - Small / (L) Front Fender, Molding - Scratch - Minimal / Front Bumper, Grille, Lamps - Scratch - Small / Bonnet, Headlight - Scratch - Small</p>
