## General Information

| Make | Toyota | Model | Vios |
| Registration No. | DBQ5034 | Chassis No. | PA1B18F37R4271539 |

## Body / Panel Condition

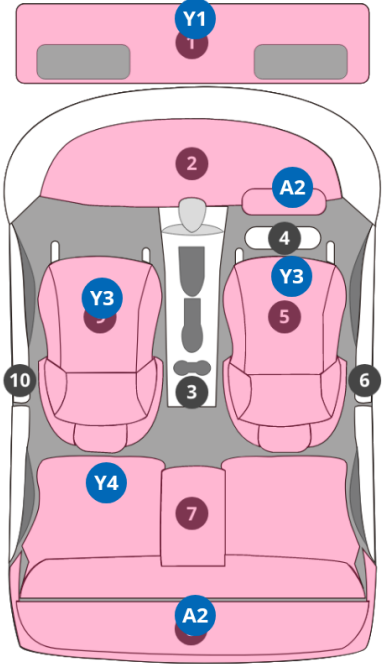
| Interior Evaluation : <b>C</b> | Exterior Evaluation : <b>E</b> |
| <p><b>Remarks</b></p> <p>Trunk Room - Worn, Scratch, Cut, Crack - Small / Rear Seat - Grime - Large / (L) Front Seat - Grime - Medium / Ceiling - Grime - Minimal / (R) Front Seat - Grime - Medium / Glove Box - Worn, Scratch, Cut, Crack - Small</p> | <p><b>Remarks</b></p> <p>(R) Front Fender, Molding - Scratch - Medium / (R) Step, In-panel, Side Spoiler - Modified - Medium / (R) Mirror - Scratch - Small / (R) Front Door, Molding - Scratch - Minimal / (R) Rear Door, Molding - Scratch - Small / (R) Rear Fender, Molding - Scratch &amp; Dent - Minimal / Rear Bumper, Lamps, Panels - Scratch - Minimal / Trunk Hood, Rear Gate - Scratch - Small / (L) Rear Fender, Molding - Scratch - Minimal / (L) Step, In-panel, Side Spoiler - Modified - Medium / (L) Rear Door, Molding - Repair mark - Yes / (L) Rear Door, Molding - Scratch &amp; Dent - Medium / (L) Front Door, Molding - Scratch &amp; Dent - Medium / (L) Front Fender, Molding - Scratch - Minimal / Member (Bolted) - Dent - Yes / Front Bumper, Grille, Lamps - Repair mark - Yes / Front Bumper, Grille, Lamps - Scratch - Medium / (L) Mirror - Scratch - Minimal / Bonnet, Headlight - Scratch - Medium / Roof - Scratch - Minimal</p> |
