## General Information

| Make | Toyota | Model | Vios |
| Registration No. | NKH3071 | Chassis No. | PA1B18F3XR4273933 |

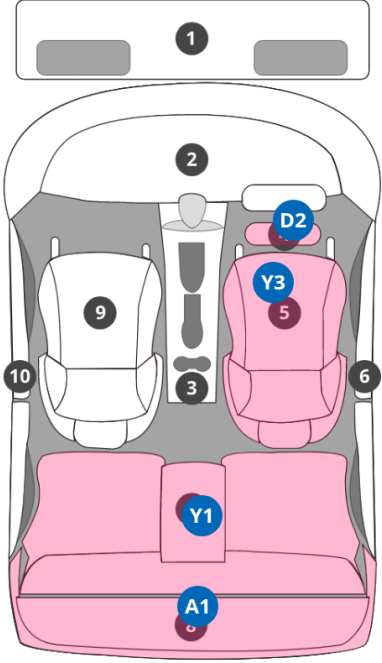
| Interior Evaluation : <b>B</b> | Exterior Evaluation : <b>B</b> |
| <p><b>Remarks</b><br/>Trunk Room - Worn, Scratch, Cut, Crack - Minimal / Rear Seat - Grime - Minimal / (R) Front Seat - Grime - Medium / (L) Front Floor Mat - Worked - Small</p> | <p><b>Remarks</b><br/>(R) Front Door, Molding - Scratch &amp; Dent - Small / (R) Rear Door, Molding - Scratch - Minimal / (R) Rear Fender, Molding - Scratch - Small / Rear Bumper, Lamps, Panels - Scratch - Medium / Trunk Hood, Rear Gate - Scratch - Minimal / (L) Rear Fender, Molding - Scratch - Minimal / (L) Rear Door, Molding - Scratch - Minimal / (L) Front Door, Molding - Scratch - Minimal / Roof Spoiler, Molding - Scratch - Minimal / (L) Front Fender, Molding - Scratch - Minimal / Front Bumper, Grille, Lamps - Scratch - Minimal / Bonnet, Headlight - Scratch - Minimal / (R) Front Fender, Molding - Scratch &amp; Dent - Minimal</p> |
