## General Information

| Make | Toyota | Model | Vios |

## Body / Panel Condition

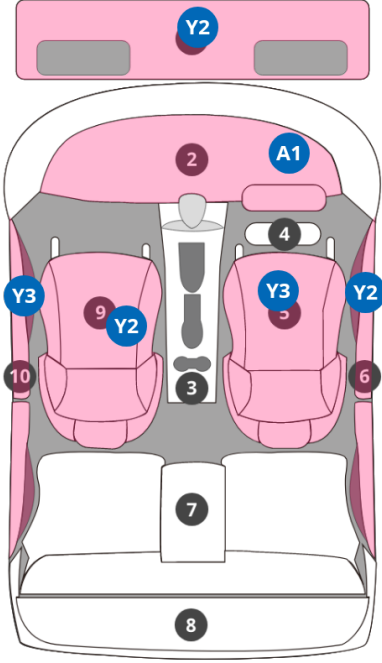
| Interior Evaluation : <b>B</b> | Exterior Evaluation : <b>B</b> |
|---|---|
| <p><b>Remarks</b><br/>(R) Front Seat - Grime - Medium / (R) Front Trim - Grime - Small / (L) Front Seat - Grime - Small / Ceiling - Grime - Small / (L) Front Trim - Grime - Medium / Dashboard - Worn, Scratch, Cut, Crack - Minimal</p> | <p><b>Remarks</b><br/>(R) Rear Door, Molding - Dent - Small / (L) Front Door, Molding - Scratch - Small / (L) Rear Fender, Molding - Scratch - Small / (R) Rear Fender, Molding - Scratch - Minimal / Roof - Scratch - Small</p> |
