## General Information

| Make | Toyota | Model | Vios |
| YOM | 2023 | Mileage | 16,453 |
| Registration No. | DBH9477 | Chassis No. | PA1B18F35P4214866 |

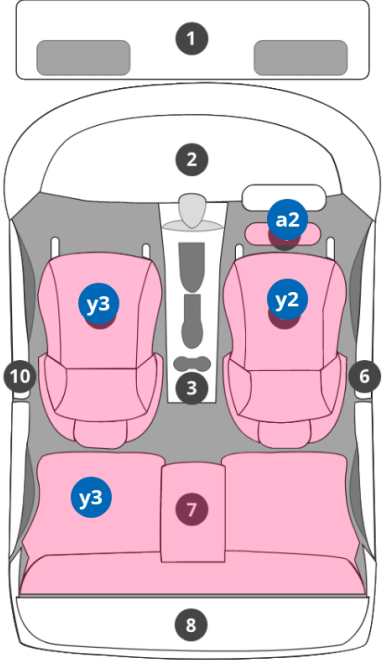
| Interior Evaluation : <b>B</b> | Exterior Evaluation : <b>A</b> |
| <b>Remarks</b><br>(L) Front Seat - Grime - Medium / (L) Front Floor Mat - Cut, Crack - Small / Rear Seat - Grime - Medium / (R) Front Seat - Grime - Small | <b>Remarks</b><br>(L) Front Door, Molding - Scratch & Dent - Minimal / Front Bumper, Grille, Lamps - Dent - Minimal / Rear Bumper, Lamps, Panels - Dent - Small / (R) Rear Door, Molding - Scratch - Minimal |

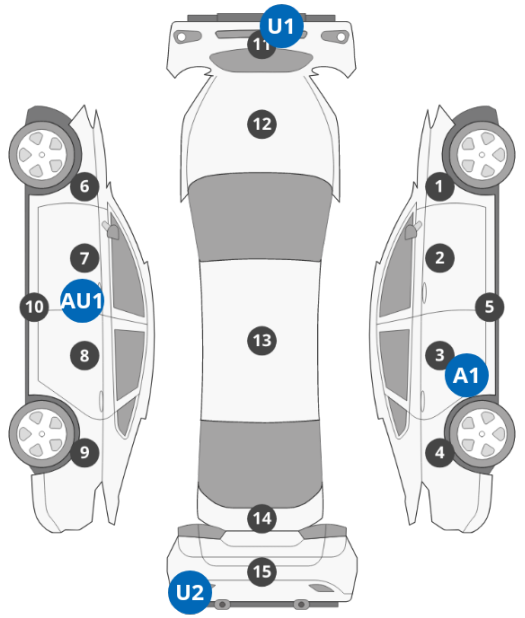
no tools. with warranty booklet and user manual. hairline scratches around the exterior.
