## General Information

| Make | Toyota | Model | Innova |
| Registration No. | DBQ6002 | Chassis No. | PA2JA8EM3R0148653 |

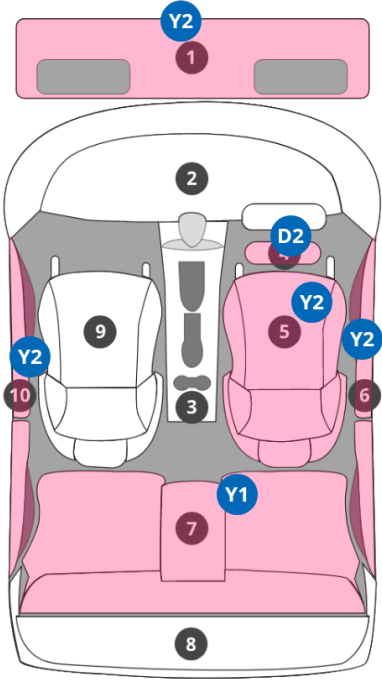
| Interior Evaluation : <b>B</b> | Exterior Evaluation : <b>D</b> |
| <b>Remarks</b><br>Rear Seat - Grime - Minimal / (R) Front Seat - Grime - Small / (L) Front Trim - Grime - Small / (R) Front Trim - Grime - Small / (L) Front Floor Mat - Worked - Small / Ceiling - Grime - Small | <b>Remarks</b><br>(R) Front Fender, Molding - Scratch - Minimal / (R) Mirror - Scratch - Minimal / (R) Front Door, Molding - Scratch & Dent - Small / (R) Rear Fender, Molding - Scratch - Small / Rear Bumper, Lamps, Panels - Scratch - Large / Trunk Hood, Rear Gate - Scratch & Dent - Small / (L) Rear Door, Molding - Scratch - Small / (L) Front Door, Molding - Scratch - Minimal / (L) Front Fender, Molding - Scratch & Dent - Large / Front Bumper, Grille, Lamps - Scratch & Dent - Large / Member (Bolted) - Dent - Yes / Bonnet, Headlight - Scratch - Small / Roof - Scratch - Small / (L) Mirror - Scratch - Medium / (L) Rear Fender, Molding - Scratch - Minimal |

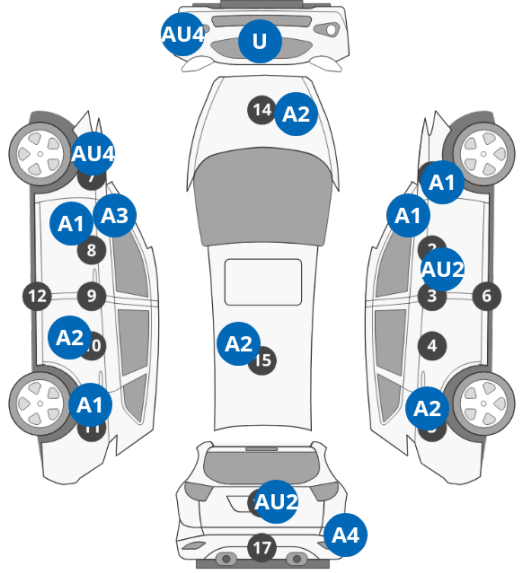
with warranty booklet, with jack and tools, with spare tire, with LTO plate, scratches on tail light
