General Information

Make	Toyota	Model	Vios
YOM	2025	Odo Meter Reading	15,321
Registration No.	DBP8811	Chassis No.	PA1B18F30R4265811
CC	1.3	Transmission	CVT
Fuel Type	Gas	Type of Body	Sedan
Colour	Red

Body / Panel Condition

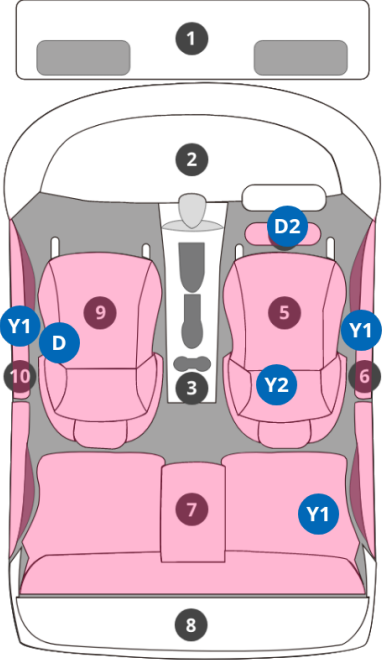
Interior Evaluation : B	Exterior Evaluation : C

<p>a : Cut, Fray d : Loose, Deformed k : Animal Hair s : Smell t : Cigarette Burns x : Defective y : Stain</p>

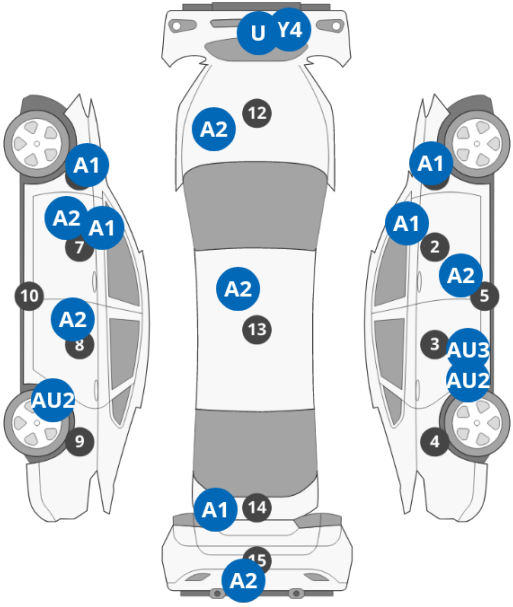
<p>A : Scratch AU : Scratch & Dent B : Modified C : Corrosion G : Stone chip P : Faded S : Rust SC : Rust & Corrosion U : Dent X : Defective Y : Crack, Gap</p>
<p>Remarks Rear Seat - Grime - Minimal / (R) Front Trim - Grime - Minimal / (R) Front Seat - Grime - Small / (L) Front Seat - Worn - Yes / (L) Front Floor Mat - Worked - Small / (L) Front Trim - Grime - Minimal</p>	<p>Remarks (R) Mirror - Scratch - Minimal / (R) Front Fender, Molding - Scratch - Minimal / (R) Rear Door, Molding - Scratch & Dent - Medium / (R) Front Door, Molding - Scratch - Small / (R) Rear Fender, Molding - Scratch & Dent - Small / Rear Bumper, Lamps, Panels - Scratch - Small / Trunk Hood, Rear Gate - Scratch - Minimal / (L) Rear Fender, Molding - Scratch & Dent - Small / (L) Rear Door, Molding - Scratch - Small / (L) Front Door, Molding - Scratch - Small / (L) Mirror - Scratch - Minimal / (L) Front Fender, Molding - Scratch - Minimal / Front Bumper, Grille, Lamps - Crack, Gap - Large / Member (Bolted) - Dent - Yes / Bonnet, Headlight - Scratch - Small / Roof - Scratch - Small</p>

<p>Inspector Notes</p>
<p>no warranty booklet, no jack and tools, no spare tire, with LTO plate, scratches on tail, power steering issue due to weak battery, temporary ORCR</p>
