## General Information

| Make | Toyota | Model | Vios |
| Registration No. | DBF6049 | Chassis No. | PA1B18F31R4241923 |

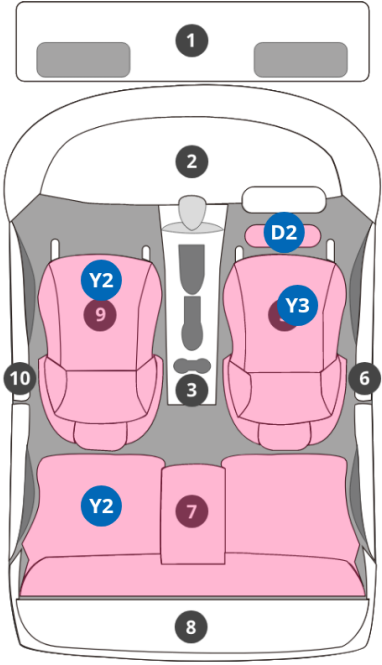
| Interior Evaluation : <b>B</b> | Exterior Evaluation : <b>B</b> |
|---|---|
| <b>Remarks</b><br>Rear Seat - Grime - Small / (R) Front Seat - Grime - Medium / (L) Front Seat - Grime - Small / (L) Front Floor Mat - Worked - Small | <b>Remarks</b><br>(R) Front Fender, Molding - Scratch - Minimal / (R) Front Door, Molding - Scratch - Minimal / (R) Rear Fender, Molding - Scratch - Minimal / (R) Rear Door, Molding - Scratch - Minimal / Rear Bumper, Lamps, Panels - Scratch - Minimal / Trunk Hood, Rear Gate - Scratch - Minimal / (L) Rear Fender, Molding - Scratch & Dent - Minimal / (L) Rear Door, Molding - Scratch - Small / (L) Front Door, Molding - Scratch - Small / (L) Front Fender, Molding - Scratch - Minimal / Front Bumper, Grille, Lamps - Scratch - Small / Bonnet, Headlight - Scratch - Minimal / Roof - Scratch - Minimal |
