## General Information

| Make | Toyota | Model | Avanza |
| Registration No. | NHI3929 | Chassis No. | MHFAA12BY2P0012501 |

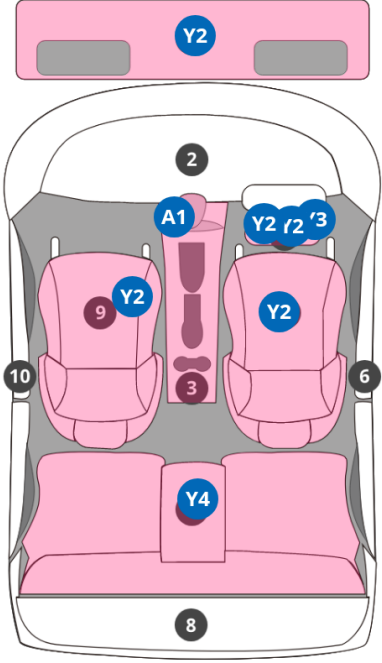
| Interior Evaluation : <b>C</b> | Exterior Evaluation : <b>E</b> |
|---|---|
| <p><b>Remarks</b></p> <p>(R) Front Floor Mat - Grime - Medium / (R) Front Seat - Grime - Small / Rear Seat - Grime - Large / Ceiling - Grime - Small / Mat Other - Grime - Small / (L) Front Seat - Grime - Small / (L) Front Floor Mat - Grime - Small / Console, Switchs, Vents - Worn, Scratch, Cut, Crack - Minimal</p> | <p><b>Remarks</b></p> <p>(R) Front Fender - Repair Traces - Yes / (R) Rear Door - Repair Traces - Yes / Front Bumper, Grille, Lamps - Scratch &amp; Dent - Large / Bonnet, Headlight - Repair mark - Yes / Bonnet, Headlight - Scratch &amp; Dent - Small / (R) Front Fender, Molding - Scratch - Small / (R) Mirror - Scratch - Minimal / (R) Front Door, Molding - Scratch - Minimal / (R) Rear Door, Molding - Scratch - Small / (R) Rear Fender, Molding - Scratch &amp; Dent - Medium / (R) Step, In-panel, Side Spoiler - Scratch - Small / Rear Bumper, Lamps, Panels - Scratch &amp; Dent - Large / Trunk Hood, Rear Gate - Scratch &amp; Dent - Medium / (L) Rear Fender, Molding - Scratch - Small / (L) Rear Door, Molding - Scratch - Small / (L) Mirror - Scratch - Small / (L) Front Door, Molding - Scratch - Minimal / (L) Front Fender, Molding - Scratch - Small / Roof - Dent - Small</p> |
