## General Information

| Make | Toyota | Model | Avanza |
| Registration No. | CCP2193 | Chassis No. | MHFAABY2S0038394 |

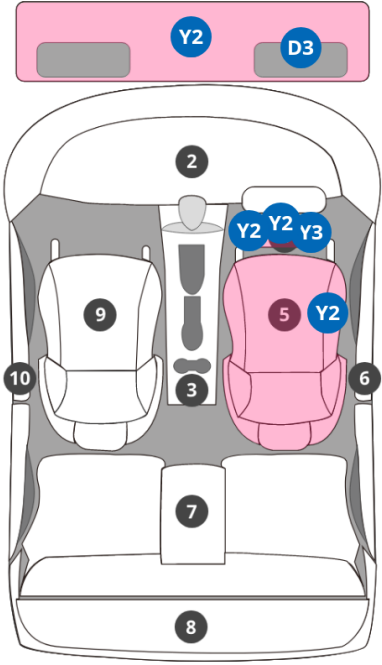
| Interior Evaluation : <b>B</b> | Exterior Evaluation : <b>C</b> |
|---|---|
| <p><b>Remarks</b></p> <p>Ceiling - Grime - Small / (R) Front Floor Mat - Grime - Medium / (R) Front Seat - Grime - Small / Mat Other - Grime - Small / (L) Front Floor Mat - Grime - Small / Sunvisor, Sunglass Holder - Crinkle - Medium</p> | <p><b>Remarks</b></p> <p>Member (Bolted) - Dent - Yes / Bonnet, Headlight - Scratch &amp; Dent - Large / Front Bumper, Grille, Lamps - Scratch &amp; Dent - Large / (R) Step, In-panel, Side Spoiler - Scratch - Minimal / (R) Rear Fender, Molding - Scratch - Small / (L) Rear Fender, Molding - Scratch &amp; Dent - Large / Rear Bumper, Lamps, Panels - Scratch - Small / (L) Rear Door, Molding - Scratch - Minimal / (L) Front Door, Molding - Scratch - Small / (L) Front Fender, Molding - Scratch - Small</p> |

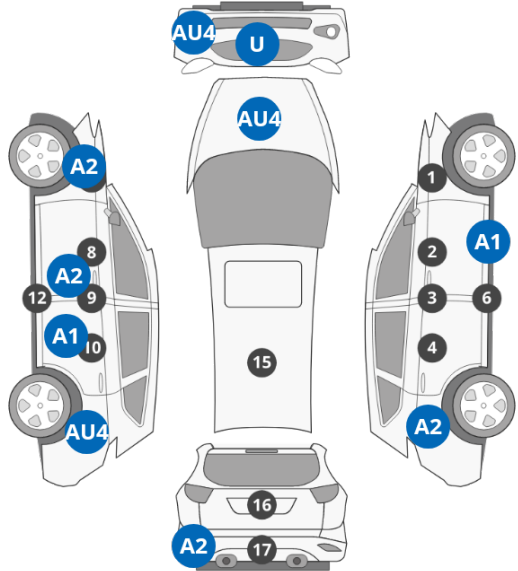
Damaged frontbumper and hood/bonnet. Left headlight issue. Left signal light issue. With warranty booklet, spare tire and jack. Without tools and seat cover. 2 keys. LTO plate not installed in this unit.
