## General Information

| Make | Toyota | Model | Vios |
| YOM | 2023 | Mileage | 18,954 |

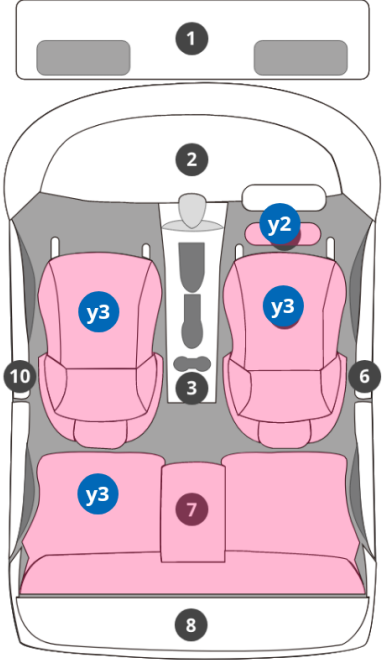
| <b>Remarks</b><br>(L) Front Seat - Grime - Medium / Rear Seat - Grime - Medium / (R) Front Floor Mat - Grime - Small / (R) Front Seat - Grime - Medium | <b>Remarks</b><br>(R) Front Fender - Repair Traces - Yes / Bonnet - Repair Traces - Yes / (L) Front Fender - Repair Traces - Yes / (L) Front Door, Molding - Scratch & Dent - Medium / Front Bumper, Grille, Lamps - Scratch - Small / Trunk Hood, Rear Gate - Scratch & Dent - Small / Rear Bumper, Lamps, Panels - Scratch & Dent - Medium / (R) Rear Door, Molding - Scratch - Minimal |

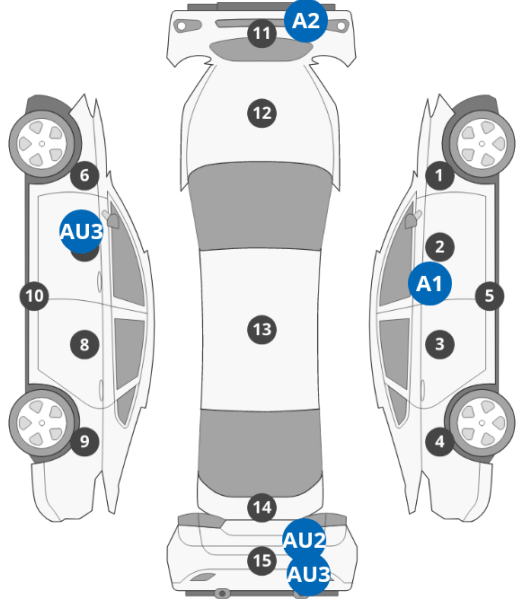
| Inspector Notes |
|---|
| hairline scratches around the exterior. With warranty booklet, user manual and tools. |
