## General Information

| Make | Toyota | Model | Vios |

## Body / Panel Condition

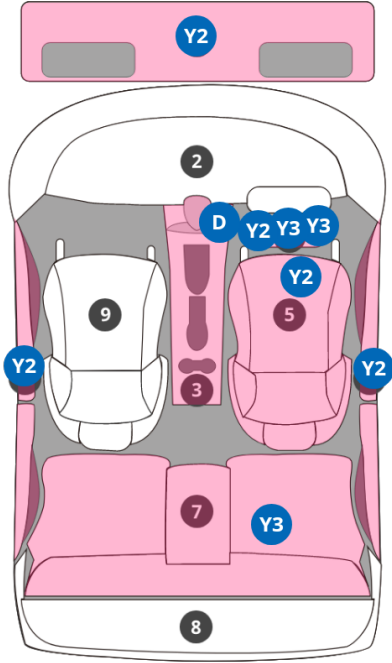
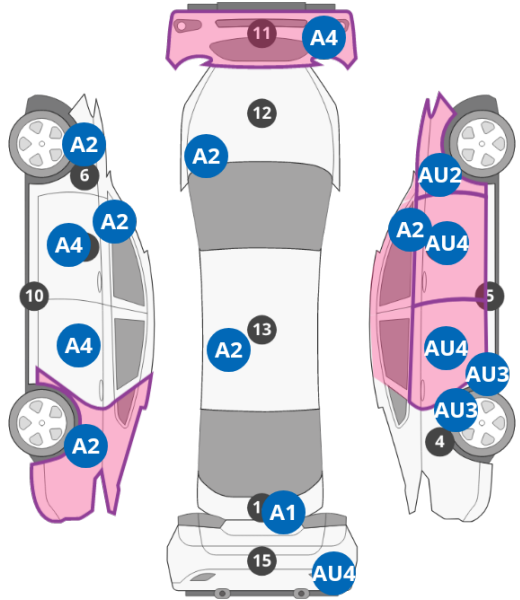
| Interior Evaluation : <b>C</b> | Exterior Evaluation : <b>E</b> |
|---|---|
| <p><b>a</b> : Cut, Fray <b>d</b> : Loose, Deformed <b>k</b> : Animal Hair <b>s</b> : Smell <b>t</b> : Cigarette Burns <b>x</b> : Defective <b>y</b> : Stain</p> | <p><b>A</b> : Scratch <b>AU</b> : Scratch &amp; Dent <b>B</b> : Modified <b>C</b> : Corrosion <b>G</b> : Stone chip <b>P</b> : Faded <b>S</b> : Rust <b>SC</b> : Rust &amp; Corrosion <b>U</b> : Dent <b>X</b> : Defective <b>Y</b> : Crack, Gap</p> |
| <p><b>Remarks</b></p> <p>Ceiling - Grime - Small / (R) Front Trim - Grime - Small / (R) Front Floor Mat - Grime - Medium / (R) Front Seat - Grime - Small / Rear Seat - Grime - Medium / Mat Other - Grime - Medium / (L) Front Trim - Grime - Small / (L) Front Floor Mat - Grime - Small / Console, Switches, Vents - Traces of Adhesive Tape - Yes</p> | <p><b>Remarks</b></p> <p>(L) Rear Door, Molding - Scratch - Large / (L) Front Door, Molding - Scratch - Large / (L) Front Fender, Molding - Scratch - Small / (L) Mirror - Scratch - Small / Front Bumper, Grille, Lamps - Repair mark - Yes / (R) Front Fender, Molding - Repair mark - Yes / Front Bumper, Grille, Lamps - Scratch - Large / (R) Front Fender, Molding - Scratch &amp; Dent - Small / (R) Mirror - Scratch - Small / (R) Front Door, Molding - Repair mark - Yes / (R) Rear Door, Molding - Repair mark - Yes / (R) Rear Door, Molding - Scratch &amp; Dent - Large / (R) Rear Fender, Molding - Scratch &amp; Dent - Medium / (R) Step, In-panel, Side Spoiler - Scratch &amp; Dent - Medium / Rear Bumper, Lamps, Panels - Scratch &amp; Dent - Large / Trunk Hood, Rear Gate - Scratch - Minimal / (L) Rear Fender, Molding - Repair mark - Yes / (L) Rear Fender, Molding - Scratch - Small / Roof - Scratch - Small / Bonnet, Headlight - Scratch - Small / (R) Front Door, Molding - Scratch &amp; Dent - Large</p> |
