## General Information

| Make | Toyota | Model | Vios |
| YOM | 2023 | Odo Meter Reading | 43,177 |

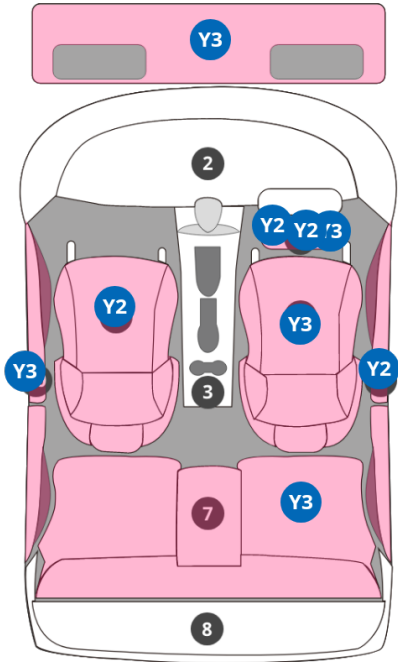
| Interior Evaluation : <span style="color: red;">C</span> | Exterior Evaluation : <span style="color: red;">C</span> |
|---|---|
| <p><b>Remarks</b></p> <p>Ceiling - Grime - Medium / (R) Front Trim - Grime - Small / (R) Front Seat - Grime - Medium / (R) Front Floor Mat - Grime - Medium / Rear Seat - Grime - Medium / Mat Other - Grime - Small / (L) Front Trim - Grime - Medium / (L) Front Seat - Grime - Small / (L) Front Floor Mat - Grime - Small</p> | <p><b>Remarks</b></p> <p>Trunk Hood, Rear Gate - Repair Traces - Yes / (L) Mirror - Scratch - Minimal / (R) Rear Door, Molding - Scratch - Large / (R) Rear Fender, Molding - Scratch - Medium / Rear Bumper, Lamps, Panels - Scratch - Small / (L) Rear Door, Molding - Scratch - Small / (L) Rear Fender, Molding - Scratch - Minimal / (L) Front Door, Molding - Scratch - Small / Front Bumper, Grille, Lamps - Scratch - Medium / Bonnet, Headlight - Scratch - Small / (R) Front Door, Molding - Scratch - Small</p> |

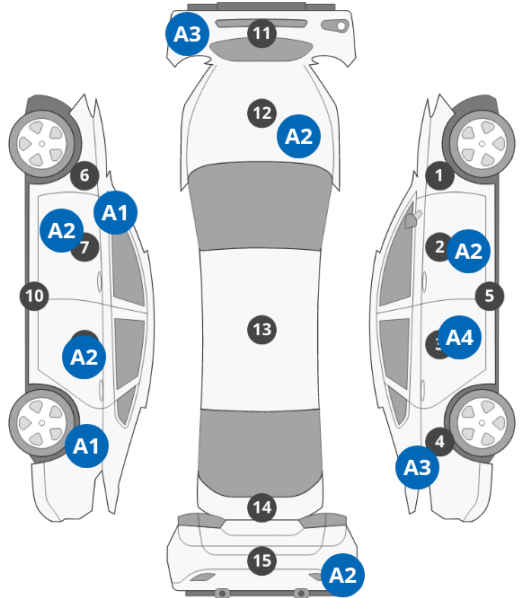
Scratches on taillight. With warranty booklet, spare tire, jack and tools. Without seat cover. 1 key. With LTO plate.
