## General Information

| Make | Toyota | Model | Vios |
| Registration No. | NFC7282 | Chassis No. | PA1B18F30P4222602 |

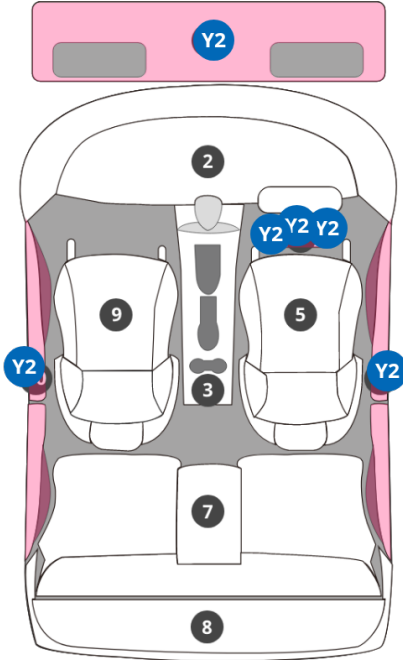
| Interior Evaluation : <span style="float: right;">B</span> | | Exterior Evaluation : <span style="float: right;">B</span> | |
|---|--|---|--|
| <b>Remarks</b><br>Ceiling - Grime - Small / (R) Front Trim - Grime - Small / (R) Front Floor Mat - Grime - Small / Mat Other - Grime - Small / (L) Front Trim - Grime - Small / (L) Front Floor Mat - Grime - Small | | <b>Remarks</b><br>(L) Rear Fender - Repair Traces - Yes / (L) Rear Door, Molding - Scratch - Small / (L) Mirror - Scratch - Minimal / (L) Front Fender, Molding - Scratch - Minimal / (L) Front Door, Molding - Scratch - Minimal / Front Bumper, Grille, Lamps - Scratch & Dent - Medium / (R) Front Door, Molding - Scratch - Small / (R) Rear Door, Molding - Scratch - Minimal / Trunk Hood, Rear Gate - Scratch - Small / Rear Bumper, Lamps, Panels - Scratch - Medium | |
