## General Information

| Make | Toyota | Model | Vios |
| YOM | 2025 | Odo Meter Reading | 16,661 |
| Registration No. | CCG1319 | Chassis No. | PA1B18F36R4277963 |

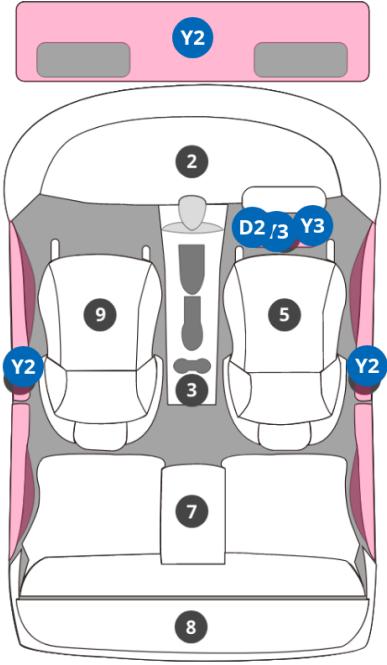
| Interior Evaluation : <b>B</b> | Exterior Evaluation : <b>C</b> |
|---|---|
| <b>Remarks</b><br>Ceiling - Grime - Small / (R) Front Trim - Grime - Small / (R) Front Floor Mat - Grime - Medium / Mat Other - Grime - Medium / (L) Front Trim - Grime - Small / (L) Front Floor Mat - Worked - Small | <b>Remarks</b><br>(L) Rear Door, Molding - Scratch & Dent - Small / (L) Mirror - Scratch - Minimal / (L) Front Door, Molding - Scratch - Small / (L) Front Fender, Molding - Scratch - Minimal / Front Bumper, Grille, Lamps - Scratch - Small / Bonnet, Headlight - Scratch - Small / (R) Front Door, Molding - Scratch - Small / (R) Rear Door, Molding - Scratch - Small / (R) Rear Fender, Molding - Scratch - Small / Rear Bumper, Lamps, Panels - Scratch - Medium / (L) Rear Fender, Molding - Scratch - Small / Trunk Hood, Rear Gate - Scratch - Small |

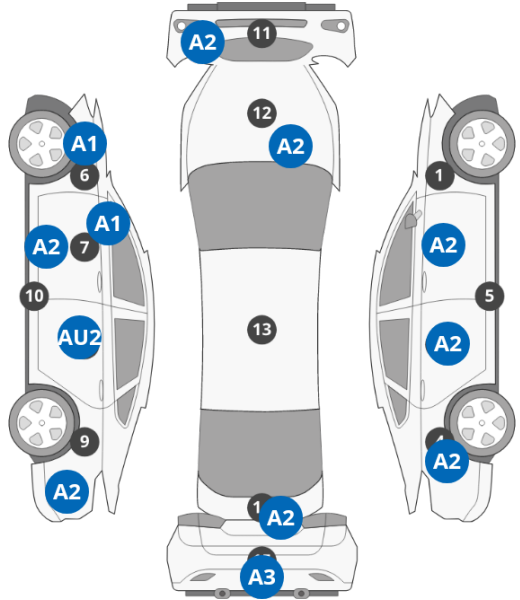
| Inspector Notes |
|---|
| Scratches at taillight. Without warranty booklet, spare tire and tools. With jack and seat cover. 3 keys. With LTO plate. |
