## General Information

| Make | Toyota | Model | Vios |
| Registration No. | BAG2726 | Chassis No. | PA1B18F36R4252531 |

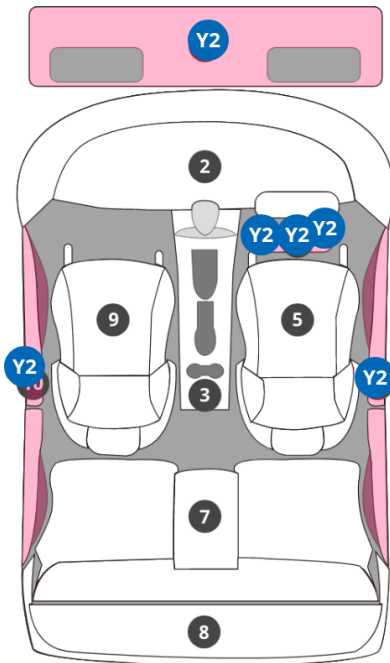
| Interior Evaluation : <b>B</b> | Exterior Evaluation : <b>B</b> |
|---|---|
| <b>Remarks</b><br>Ceiling - Grime - Small / (R) Front Trim - Grime - Small / (R) Front Floor Mat - Grime - Small / Mat Other - Grime - Small / (L) Front Trim - Grime - Small / (L) Front Floor Mat - Grime - Small | <b>Remarks</b><br>Front Bumper, Grille, Lamps - Scratch - Small / (L) Mirror - Scratch - Minimal / (L) Front Fender, Molding - Scratch & Dent - Small / Trunk Hood, Rear Gate - Scratch - Small / (R) Rear Door, Molding - Scratch - Minimal / (R) Front Door, Molding - Scratch & Dent - Minimal / (R) Mirror - Scratch - Small / Bonnet, Headlight - Scratch - Small / (L) Rear Fender, Molding - Scratch & Dent - Small / Rear Bumper, Lamps, Panels - Scratch - Small |
