## General Information

| Make | Toyota | Model | Innova |
| Registration No. | BAG3929 | Chassis No. | PA2JA8EM2R0142097 |

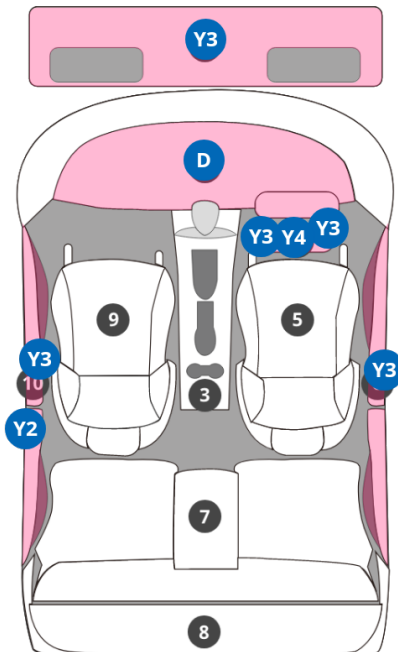
| Interior Evaluation : <span style="color: red;">C</span> | Exterior Evaluation : <span style="color: red;">B</span> |
| <b>Remarks</b><br>(R) Front Trim - Grime - Medium / (R) Front Floor Mat - Grime - Medium / Dashboard - Traces of Adhesive Tape - Yes / Mat Other - Grime - Large / Ceiling - Grime - Medium / (L) Rear Trim - Grime - Small / (L) Front Trim - Grime - Medium / (L) Front Floor Mat - Grime - Medium | <b>Remarks</b><br>(L) Rear Fender, Molding - Scratch & Dent - Medium / Rear Bumper, Lamps, Panels - Scratch - Small / (R) Rear Door, Molding - Scratch - Minimal / (R) Front Fender, Molding - Scratch - Minimal / Front Bumper, Grille, Lamps - Scratch - Medium / (L) Front Fender, Molding - Scratch - Minimal / (L) Step, In-panel, Side Spoiler - Scratch - Small |

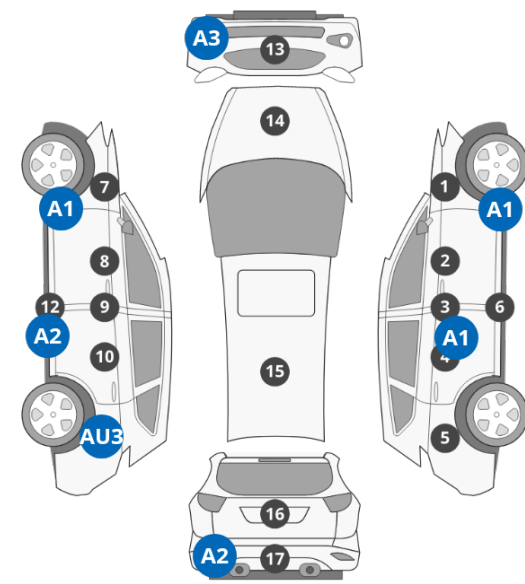
Low battery. Crack and scratches on taillight. Sccratches on wheel cap. With warranty booklet, spare tire and seat cover. Without jack and tools. 2 keys. with LTO plate.
