General Information

Make	Hino	Model	315
YOM	2024	Odo Meter Reading	16,669
Registration No.	DBS9598	Chassis No.	JHHAGP6E3RK004456
CC	2.8	Transmission	M/T
Fuel Type	Diesel	Type of Body	Aluminum Van
Colour	White

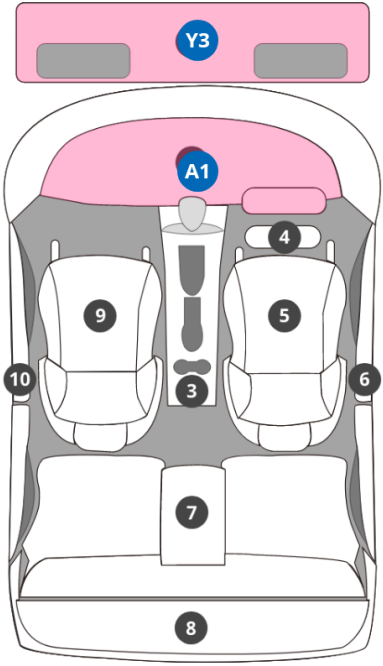
Interior Evaluation : B	Exterior Evaluation : D

<p>a : Cut, Fray d : Loose, Deformed k : Animal Hair s : Smell t : Cigarette Burns x : Defective y : Stain</p>

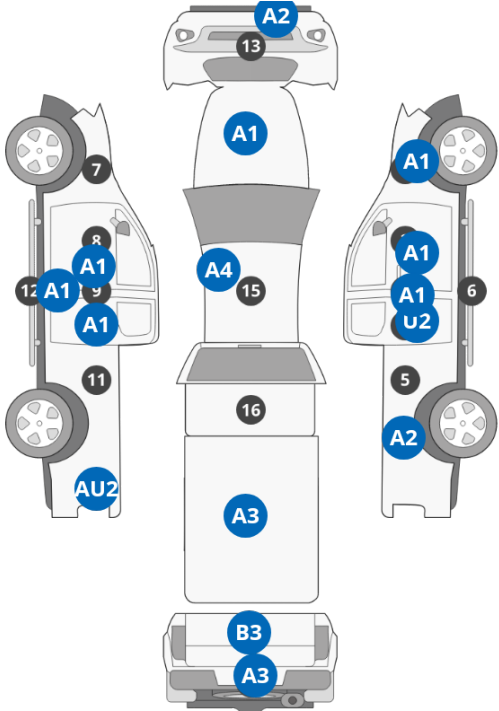
<p>A : Scratch AU : Scratch & Dent B : Modified C : Corrosion G : Stone chip P : Faded S : Rust SC : Rust & Corrosion U : Dent X : Defective Y : Crack, Gap</p>
<p>Remarks Dashboard - Worn, Scratch, Cut, Crack - Minimal / Ceiling - Grime - Medium</p>	<p>Remarks (R) Rear Door - Repair Traces - Yes / (R) Front Fender, Molding - Scratch - Minimal / (R) Front Door, Molding - Scratch - Minimal / (R) Rear Door, Molding - Dent - Small / (R) Center Panel - Scratch - Minimal / (R) Side Gate - Scratch - Small / Rear Bumper, Lamps, Panels - Scratch - Medium / Cargo Bed Floor - Scratch - Medium / (L) Side Gate - Scratch & Dent - Small / (L) Rear Door, Molding - Scratch - Minimal / (L) Center Panel - Scratch - Minimal / (L) Front Door, Molding - Scratch - Minimal / Front Bumper, Grille, Lamps - Scratch - Small / Front Panel - Scratch - Minimal / Roof - Scratch - Large / Rear Gate - Modified - Medium</p>
