## General Information

| Make | Toyota | Model | Vios |
| Registration No. | NFF5056 | Chassis No. | PA1B18F36P4237718 |

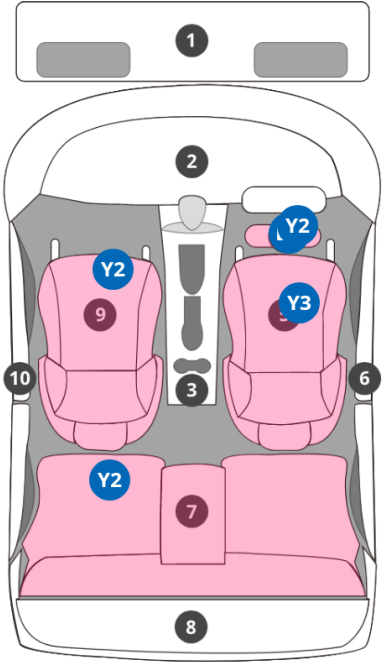
| Interior Evaluation : <b>B</b> | Exterior Evaluation : <b>C</b> |
| <b>Remarks</b><br>Rear Seat - Grime - Small / Mat Other - Crinkle - Small / (R) Front Seat - Grime - Medium / (L) Front Seat - Grime - Small / (L) Front Floor Mat - Grime - Small | <b>Remarks</b><br>(R) Front Fender, Molding - Scratch - Medium / (R) Front Door, Molding - Scratch - Medium / (R) Rear Door, Molding - Scratch - Minimal / (R) Rear Fender, Molding - Scratch - Minimal / (R) Front Wheel, Cover - Scratch, Corrosion - Small / Rear Bumper, Lamps, Panels - Scratch - Small / Trunk Hood, Rear Gate - Scratch - Small / (L) Rear Fender, Molding - Scratch - Minimal / (L) Rear Door, Molding - Scratch - Minimal / (L) Front Door, Molding - Scratch - Minimal / (L) Front Fender, Molding - Scratch - Minimal / Front Bumper, Grille, Lamps - Scratch - Medium / Bonnet, Headlight - Scratch - Small / Roof - Scratch - Minimal |
