## General Information

| Make | Toyota | Model | Innova |
| YOM | 2024 | Odo Meter Reading | 12,882 |
| Registration No. | NHQ5201 | Chassis No. | PA2JA8EM8R0139124 |

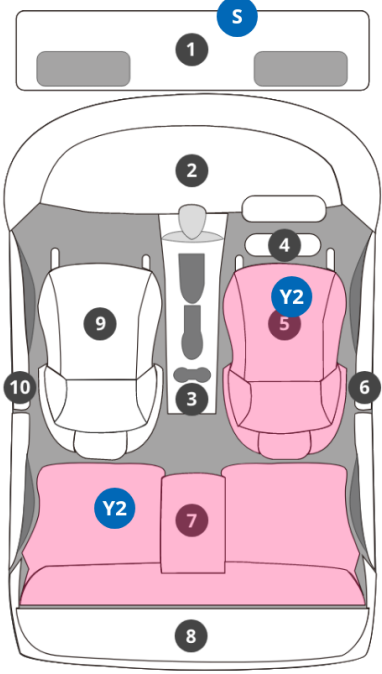
| Interior Evaluation : <b>B</b> | Exterior Evaluation : <b>C</b> |
| <p><b>Remarks</b><br/>Rear Seat - Grime - Small / (R) Front Seat - Grime - Small / Overall Interior - Smell - Yes</p> | <p><b>Remarks</b><br/>(L) Rear Fender, Molding - Scratch - Minimal / (L) Rear Door, Molding - Scratch - Minimal / (L) Front Door, Molding - Scratch - Small / (L) Front Fender, Molding - Scratch - Small / Front Bumper, Grille, Lamps - Scratch &amp; Dent - Medium / Member (Bolted) - Dent - Yes / Bonnet, Headlight - Scratch - Small / (R) Front Fender, Molding - Scratch - Minimal / (R) Front Door, Molding - Scratch - Small / (R) Rear Door, Molding - Scratch - Minimal / (R) Rear Fender, Molding - Scratch - Small / Rear Bumper, Lamps, Panels - Scratch - Small / Trunk Hood, Rear Gate - Scratch - Minimal / Roof - Scratch - Small</p> |

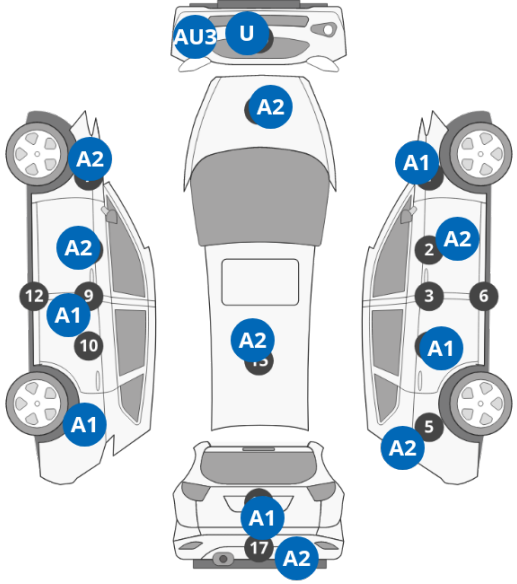
| Inspector Notes |
|---|
| With LTO plate and Sparetire and Jack and Incomplete Tools, with warranty booklet, Scratch headlight and tail light. |
