## General Information

<b>Make</b>	Toyota	<b>Model</b>	Innova
<b>YOM</b>	2025	<b>Odo Meter Reading</b>	19,776
<b>Registration No.</b>	NHU8272	<b>Chassis No.</b>	PA2JA8EMXR0151744
<b>CC</b>	2.8	<b>Transmission</b>	A/T
<b>Fuel Type</b>	Diesel	<b>Type of Body</b>	Wagon
<b>Colour</b>	Black

## Body / Panel Condition

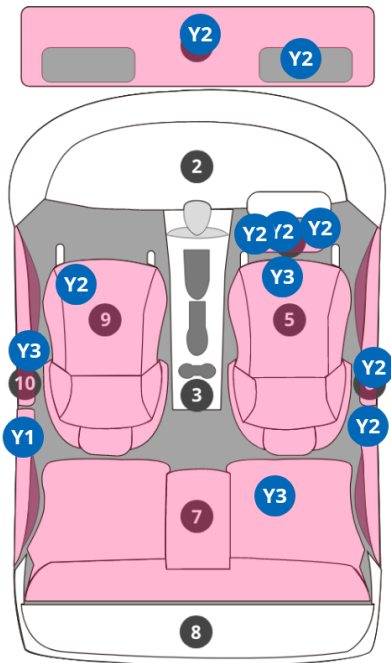
<b>Interior Evaluation :</b> <span style="float: right; color: red; font-weight: bold;">C</span>	<b>Exterior Evaluation :</b> <span style="float: right; color: red; font-weight: bold;">E</span>

<p><b>a</b> : Cut, Fray <b>d</b> : Loose, Deformed <b>k</b> : Animal Hair <b>s</b> : Smell <b>t</b> : Cigarette Burns <b>x</b> : Defective <b>y</b> : Stain</p>

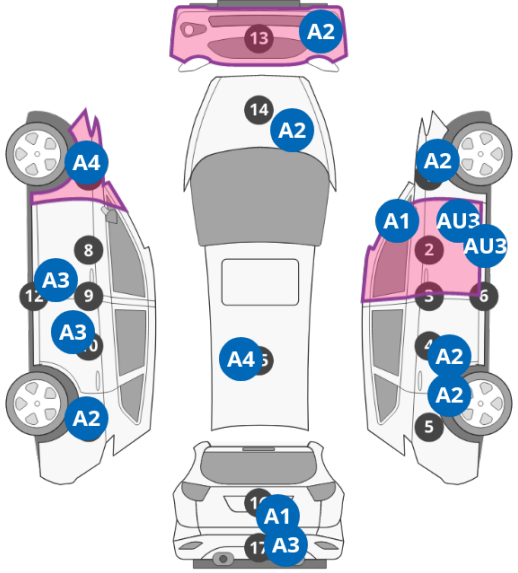
<p><b>A</b> : Scratch <b>AU</b> : Scratch &amp; Dent <b>B</b> : Modified <b>C</b> : Corrosion <b>G</b> : Stone chip <b>P</b> : Faded <b>S</b> : Rust <b>SC</b> : Rust &amp; Corrosion <b>U</b> : Dent <b>X</b> : Defective <b>Y</b> : Crack, Gap</p>
<p><b>Remarks</b> Ceiling - Grime - Small / (R) Front Trim - Grime - Small / (R) Front Seat - Grime - Medium / (R) Front Floor Mat - Grime - Small / Rear Seat - Grime - Medium / (R) Rear Trim - Grime - Small / (L) Rear Trim - Grime - Minimal / Mat Other - Grime - Small / (L) Front Trim - Grime - Medium / (L) Front Seat - Grime - Small / (L) Front Floor Mat - Grime - Small / Sunvisor, Sunglass Holder - Grime - Small</p>	<p><b>Remarks</b> (L) Front Fender - Repair Traces - Yes / (R) Rear Fender - Repair Traces - Yes / (L) Rear Door, Molding - Scratch - Medium / (L) Front Door, Molding - Scratch - Medium / (L) Front Fender, Molding - Repair mark - Yes / (L) Front Fender, Molding - Scratch - Large / Front Bumper, Grille, Lamps - Repair mark - Yes / Front Bumper, Grille, Lamps - Scratch - Small / Bonnet, Headlight - Scratch - Small / (R) Front Fender, Molding - Scratch - Small / (R) Mirror - Scratch - Minimal / (R) Rear Door, Molding - Scratch - Small / (R) Rear Fender, Molding - Scratch - Small / (R) Front Door, Molding - Scratch &amp; Dent - Medium / (R) Front Door, Molding - Repair mark - Yes / (R) Step, In-panel, Side Spoiler - Scratch &amp; Dent - Medium / Rear Bumper, Lamps, Panels - Scratch - Medium / Trunk Hood, Rear Gate - Scratch - Minimal / (L) Rear Fender, Molding - Scratch - Small / Roof - Scratch - Large</p>
