General Information

Make	Toyota	Model	Vios
YOM	2024	Mileage	10,169
Registration No.	NHH5366	Chassis No.	PA1B18F33R4252020
CC	1.3	Transmission	CVT
Fuel Type	Gas	Type of Body	Sedan
Colour	Silver

Body / Panel Condition

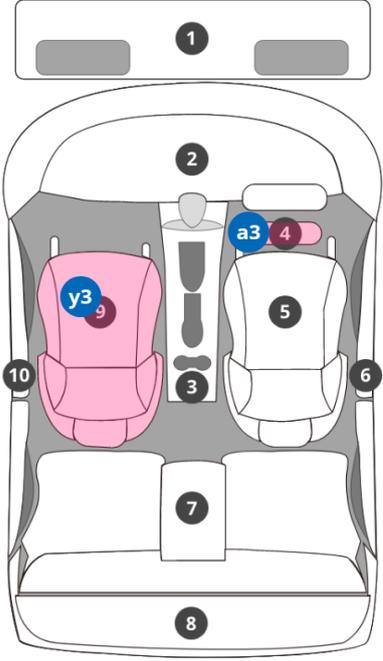
<p>a : Cut, Fray d : Loose, Deformed k : Animal Hair s : Smell t : Cigarette Burns x : Defective y : Stain</p>

<p>A : Scratch AU : Scratch & Dent B : Modified C : Corrosion G : Stone chip P : Faded S : Rust SC : Rust & Corrosion U : Dent X : Defective Y : Crack, Gap</p>
<p>Remarks (L) Front Seat - Grime - Medium / (L) Front Floor Mat - Cut, Crack - Medium</p>	<p>Remarks Trunk Hood, Rear Gate - Dent - Small / Rear Bumper, Lamps, Panels - Dent - Small / Front Bumper, Grille, Lamps - Scratch - Medium / Roof - Scratch - Small</p>
Frame Evaluation : A	Functional Evaluation : A
<p>Remarks Defects not found</p>	<p>Remarks Spare Key - Issue - Unexist</p>
