## General Information

| Make | Toyota | Model | Vios |
| YOM | 2024 | Odo Meter Reading | 57,841 |
| Registration No. | NHR1931 | Chassis No. | PA1B18F30P4227203 |

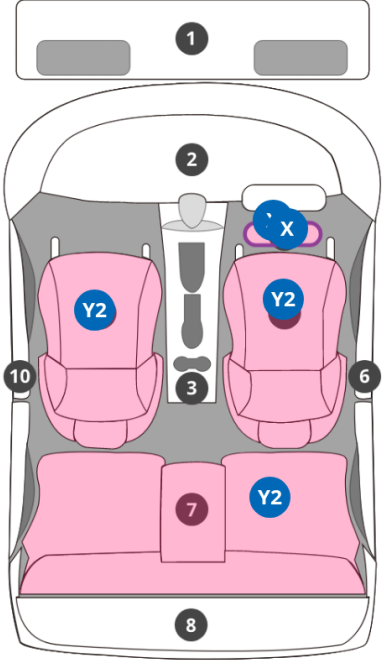
| Interior Evaluation : <b>B</b> | Exterior Evaluation : <b>C</b> |
| <p><b>Remarks</b><br/>Rear Seat - Grime - Small / (L) Front Seat - Grime - Small / (L) Front Floor Mat - Missing - Yes / (R) Front Floor Mat - Missing - Yes / (R) Front Seat - Grime - Small</p> | <p><b>Remarks</b><br/>Member (Bolted) - Dent - Yes / (R) Front Fender, Molding - Scratch - Minimal / (R) Front Door, Molding - Scratch - Minimal / (R) Rear Door, Molding - Scratch - Small / (R) Rear Fender, Molding - Scratch &amp; Dent - Small / Trunk Hood, Rear Gate - Scratch &amp; Dent - Small / Rear Bumper, Lamps, Panels - Scratch - Small / (L) Rear Fender, Molding - Scratch - Small / (L) Rear Door, Molding - Scratch &amp; Dent - Minimal / (L) Front Door, Molding - Scratch &amp; Dent - Small / (L) Front Fender, Molding - Scratch - Small / Front Bumper, Grille, Lamps - Scratch - Small / Bonnet, Headlight - Scratch - Small / Roof - Scratch &amp; Dent - Small</p> |

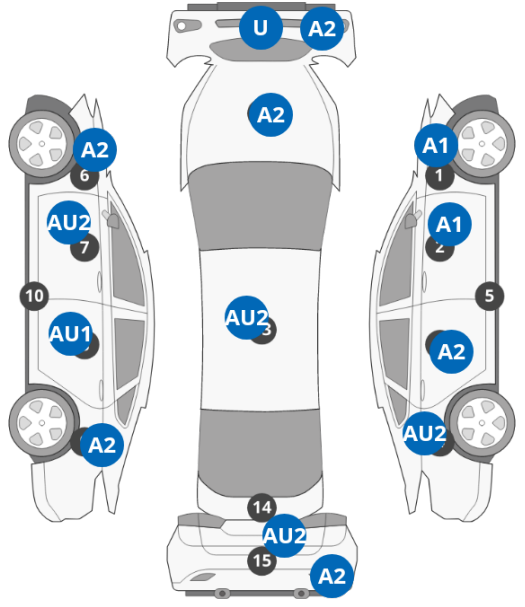
With LTO plate and Sparetire, Incomplete Tools and Jack. no warranty booklet and Crack tail light and scratch headlight and tail light and worn tires.
